MIDDLE RIO GRANDE WATERSHED BASED MUNICIPAL SEPARATE STORM SEWER (MS4) PERMIT

DRAFT
2018-2019 ANNUAL REPORT
July 1, 2018 – June 30, 2019

Development Services Department
3200 Civic Center Circle NE
Rio Rancho, NM 87144

NPDES GENERAL PERMIT NO. NMR04A000

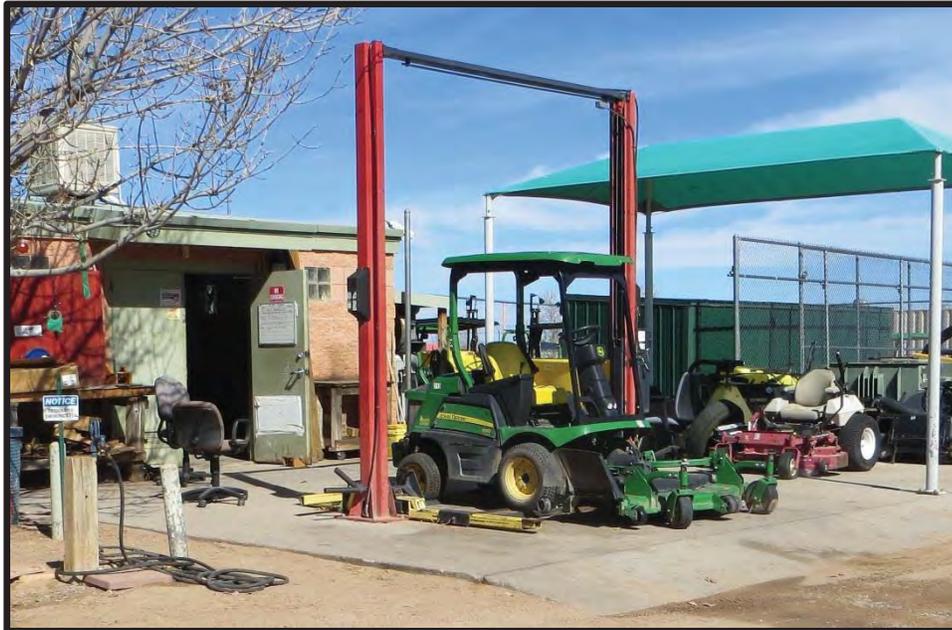
Figure 1: PRCS Maintenance Yard - Maintenance Area (March 2019)

may occur during maintenance are immediately addressed and properly cleaned up. The maintenance pad is not washed down; this action could flush accumulated oil and grease materials into the adjacent soil and potentially into stormwater runoff. Future plans for yard improvements include consideration to cover the maintenance area to provide protection from rainfall and reduce stormwater runoff from this maintenance pad.

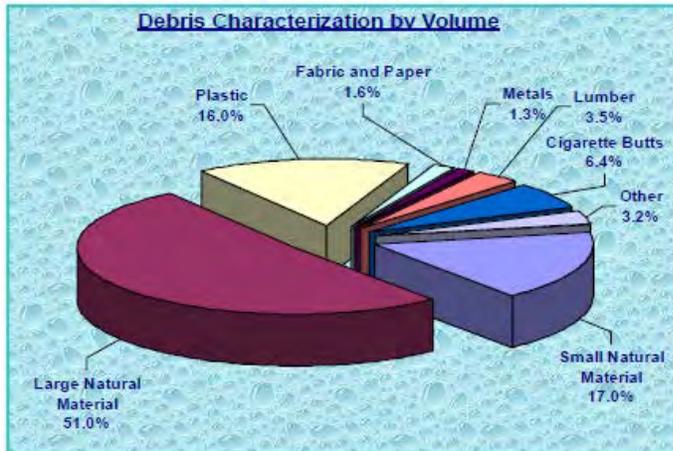
Figure 2. Distribution of Gross Pollutants by Volume (ASCG, 2005)

ASCG (2005) found the distribution of gross pollutants by volume from surveys of nine sites in the watershed (Figure 2).

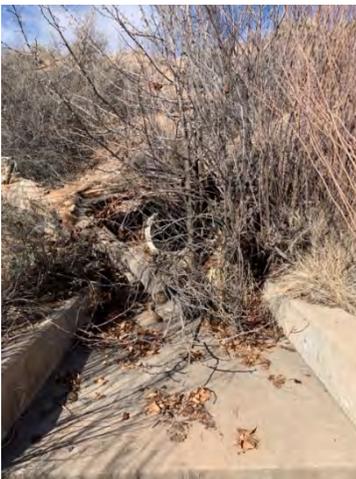
1.4.1 River's Edge #1: 24-inch RCP

The RE1 outfall is located off Black River Drive NE, and drains approximately 19.7 acres consisting of primarily single-family residential development. It consists of a pipe with a concrete rundown. RE1 is the outfall from the Parcel "I" storm drain, the inlet to which is located on Black River Drive. The Parcel "I" storm drain consists of approximately 315 linear feet of reinforced concrete pipe (RCP), in four segments between manholes; three of these segments are 24-inch-diameter and one 80-foot segment is 18-inch-

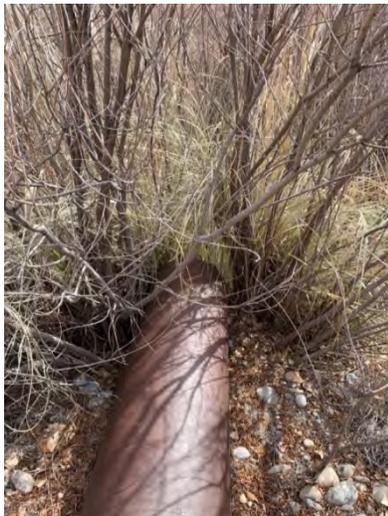
1.4.2 River’s Edge #2: 18-inch Steel

The RE2 outfall is connected to the Parcel “H” storm drain, the inlet to which is located in a cul de sac on Wolf Creek Court. The watershed is approximately 5.5 acres of single residential development. The storm drain design shows a Type Double “C” inlet and approximately 257 feet of RCP with three Type “C” or “E” 4-foot-diameter manholes. The 18-inch RCP outlet includes a sloped reinforced concrete channel that is 4 inches deep by 6 feet wide by 13 feet long.

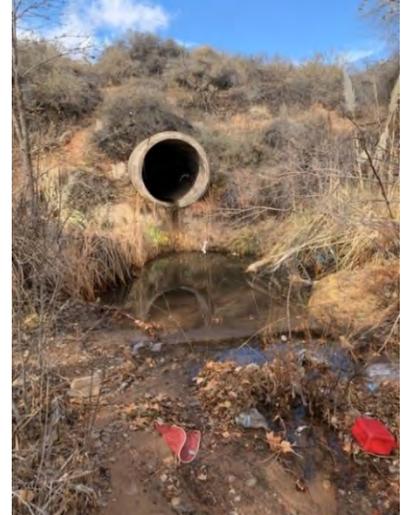
RE3 drains approximately 182.2 acres of land with single-family residential housing. The outfall is connected to the Red River Road storm drain and is located southeast of Riverside Drive. The storm drain consists of 1,452 linear feet of RCP varying in size from 24-inch to 60-inch-diameter at the outfall. The storm drain network contains 4 Type "A" inlets and 12 Type Double "C" inlets, along with 2 Type "C" or "E" 4-foot-diameter manholes, 3 Type "C" 6-foot diameter manholes, and 2 Type "C" 8-foot-diameter manholes. The outlet is 60-inch-diameter RCP that was designed with a reinforced concrete stilling basin and a soil erosion protection mat.

The concrete stilling basin and outfall were visible during the site visit (Appendix A). However, ponded water and thick vegetation impeded a complete inspection of the structure. The stilling basin design includes a 10-foot-long by 20-foot-wide reinforced concrete basin that is 1.5 feet deep. The basin transitions to a concrete outfall that is 5 feet long by 20 feet wide. The design also included a 50-foot-long by 20-foot-wide swale protected with erosion control material; however, a dense stand of vegetation has been established in this location and only a small channel is visible. Clearing and grubbing of the site will be required in order to complete a full inspection and assess the condition of the concrete structure.

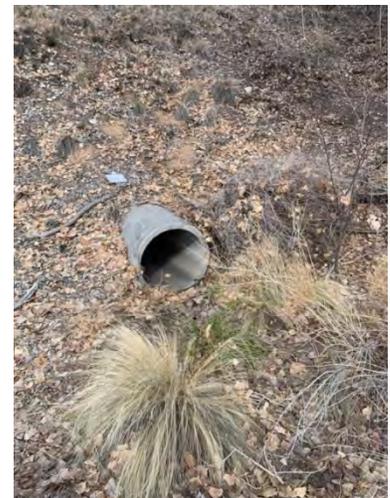
RE4 drains approximately 24.9 acres of land with single-family residential housing. The outfall is connected to Parcel "E" storm drain, which drains sections of Silver Creek Drive and Riverside Drive. The storm drain network contains one Type "A" inlet and one Type Double "C" inlet, and conveys stormwater through approximately 858 linear feet of 18-inch to 32-inch RCP at the outfall. It also contains one 4-foot-diameter manhole. This outfall was

designed similarly to that of RE3, with a reinforced concrete blanket, cutoff wall, stilling basin, outfall, and swale with erosion protection.

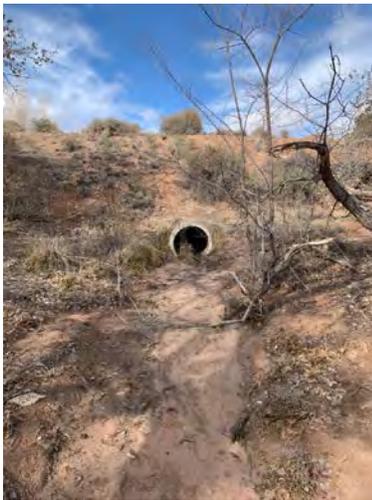
1.4.5 River's Edge #5: 48-inch RCP

RE5 drains approximately 414 acres of primarily single-family residential development. The outfall is connected to Parcel "B" storm drain, which drains a section of Willow Creek Road. Record drawings indicate that the storm drain was not constructed upstream of Willow Creek Road, although that section was included in the original design. There is a channel for stormwater conveyance upstream of that road, and flow is directed into the storm drain piping at that location, which then outfalls to the river. The channel is lined with concrete at this location.

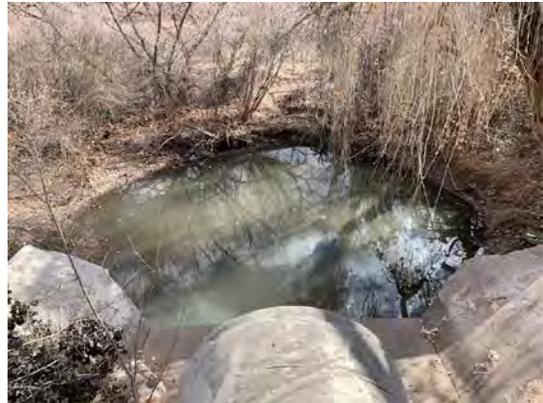
RE6 drains approximately 125 acres of single-family residential development. The outfall is connected to the Rib Mountain Road (RMR) storm drain and drains sections of Willow Creek Road and Manzano Loop. The RMR storm drain network consists of seven Type Double "C" inlets and 850 linear feet of 48-inch-diameter RCP. There are three 6-foot-diameter Type "C" manholes. The storm drain outlet was designed with concrete protection and erosion control mat. A soil erosion control mat was installed on a 32-foot by 20-foot swale. Concrete outlet protection design included a stilling basin.

The area around the concrete outlet and stilling basin shows evidence of large-scale erosion. Erosion under the structure near the transition from concrete to the earthen swale resulted in formation of a detention pond that is approximately 28 feet wide and several feet deep, as shown in Appendix A. Due to the erosion, the outfall section of concrete has broken off and is submerged in the pond.

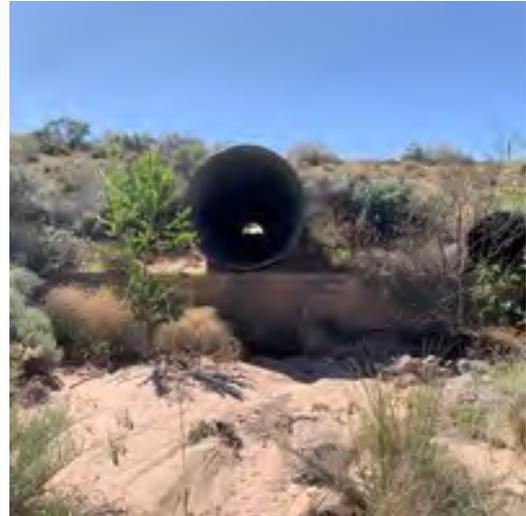
RE7 drains approximately 360 acres of primarily single-family residential development, including portions of NM 528 and Willow Creek Road. Beginning at NM 528, the stormwater flows for approximately 2,000 feet through an open earthen trapezoidal channel that is constructed with a series of drop structures that maintain a channel slope of -0.515 percent. Water is concentrated into a 66-inch-diameter corrugated metal pipe (CMP) where it travels under Willow Creek Road.

Similar to outfalls RE3 through RE6, the culvert discharges into a reinforced concrete stilling basin. The floor of the basin is 6 feet below the pipe invert, and is constructed with a 14-foot-wide by 10-foot-long basin that is 1.5 feet deep. A second 36-inch-diameter corrugated plastic pipe drains an area to the north and discharges into the same structure approximately 15 feet to the north. Riprap protection lines the banks of the channel for a short distance downstream of the culvert. After flowing through a section of dense vegetation including a stand of cottonwoods, the water is concentrated into a narrow concrete structure that is approximately 6 feet tall with steep side slopes, 20 feet long with a bottom width of 6 feet. Downstream of this structure, the water flows through a constructed arroyo with drop structures and erosion protection.

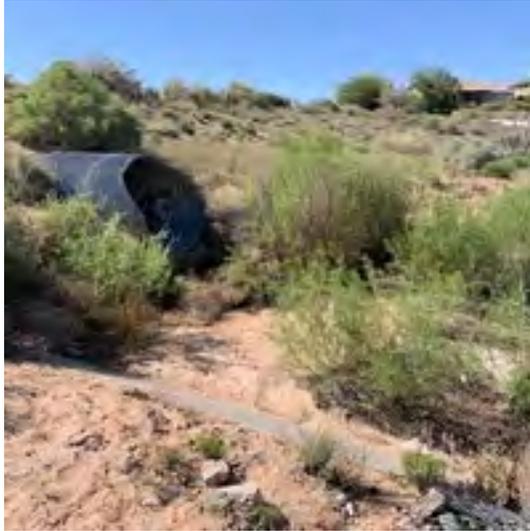
1.4.8 River's Edge #8: 66-inch CMP

RE8 drains approximately 691 acres of land consisting primarily of single-family residential development. The RE8 channel drains an area west of NM 528 and Willow Creek Road. Beginning at NM 528, the earthen trapezoidal channel is composed of a series of stabilizer walls and drop structures that maintain a channel slope of -0.047 percent. Water flows in this channel for approximately 1,050 feet until it transitions to concrete as it approaches Willow Creek Road. Water then flows through a 66-inch-diameter CMP where it is discharged into a concrete stilling basin downstream of the bridge.

The stilling basin floor is 6 feet below the pipe invert and was constructed with a 14-foot-wide by 10-foot-long basin that is 1.5 feet deep. The outfall for the structure is 20 feet wide with 2H:1V side slopes. Downstream of the concrete outfall, the channel shows signs of large-scale erosion. Wire-enclosed riprap blankets that used to flank the channel have been undercut by erosion and are no longer protecting the channel banks. There are large piles of concrete debris along with old tires at several locations, which appear to have been placed for erosion protection.

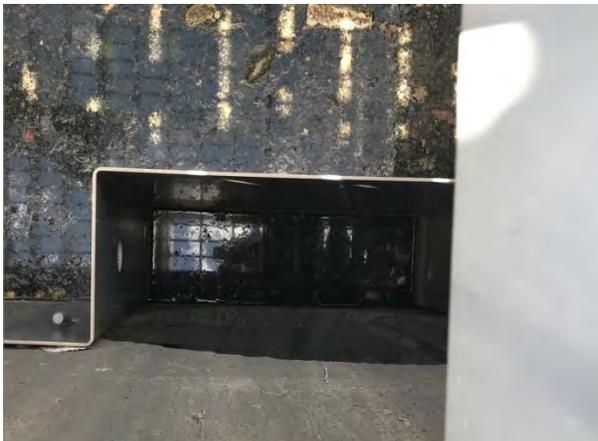
Figure 4. Installed Inlet Guard

Inlet guards are a low-cost, effective method for capturing gross pollutants. They consist of a metal plate that is installed in front of the outlet and acts to block pollutants from directly entering the storm sewer system. Under normal conditions, water flows through a gap beneath the guard and the base of the inlet structure. During periods of high flow, water can enter the inlet through the top of the guard, which has the potential for gross pollutants to pass through. Gross pollutants are captured and stored in the structure (manhole or inlet box) in which the guard is installed. Maintenance is accomplished by removing the inlet grate and removing the pollutants either manually or with a vacuum truck. Figure 4 shows a photograph of an inlet guard that is installed at Southern and NM 528. Routine inspections are required in order to minimize the buildup of pollutants to ensure that they do not pass over the guard.

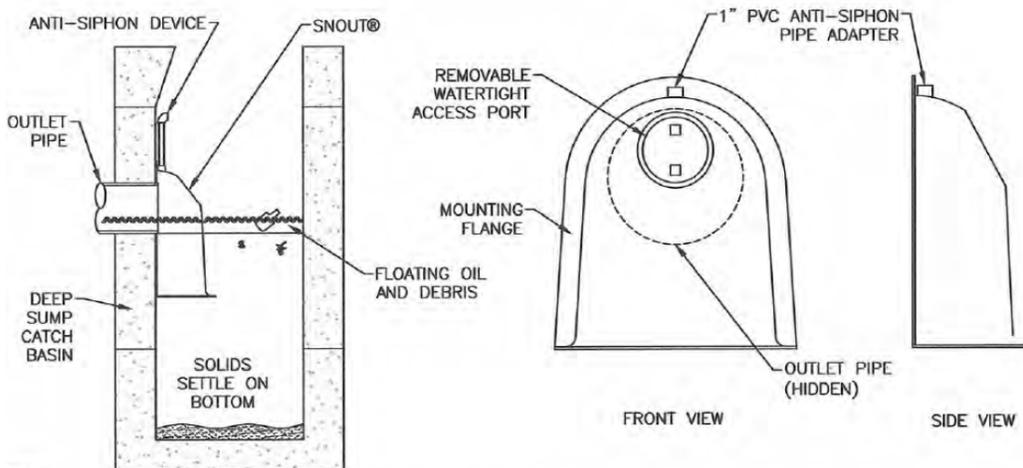
Figure 5. Manhole Guard

Manhole guards can be very effective, removing more than 80 percent of gross pollutants and 60 percent of hydrocarbons. They function similarly to the inlet guard, in that they do not allow pollutants to pass directly through the manhole. The guard extends below the invert of the pipe into the manhole sump, which acts to inhibit the passing of pollutants to the outlet. It relies on differences in density between water and the gross pollutants for removal. Maintenance is completed using a vacuum truck, and is recommended after each major storm event. Figure 5 provides a detail of an installation in a manhole.

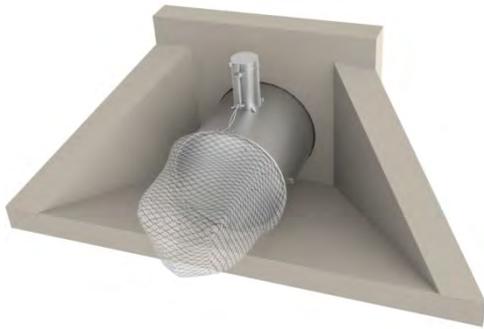
Figure 6. End of Pipe Netting

Netting systems have undergone a number of field trials including pilot studies, primarily under rainfall conditions typical of the mid-Atlantic states. These products performed very well for gross pollutant removal and are a relatively low-cost solution under the conditions tested. They can be installed directly on the end of an outfall (Figure 6), or can be installed in-line with the channel (Figure 7). Maintenance involves the removal and emptying of the nets, typically with a boom truck, with periodic replacement depending on several factors. Nets are available in heavy weights that are reported to perform well under high-flow conditions.

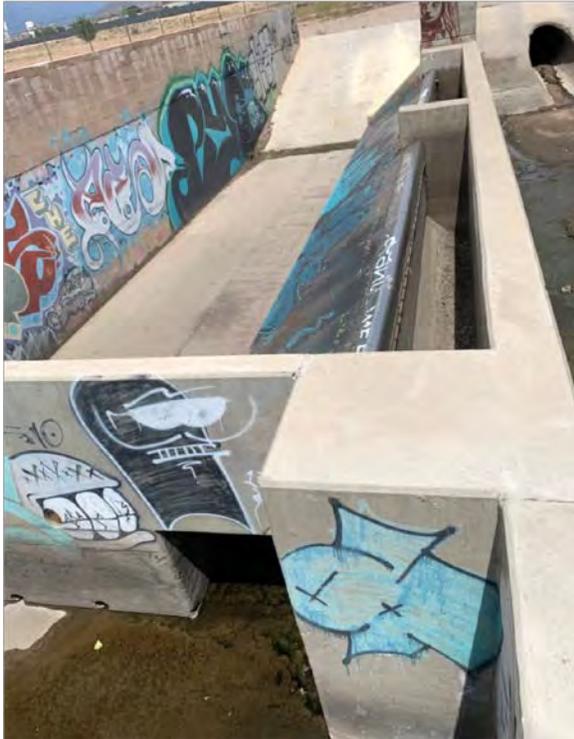
Figure 9. AMAFCA Structure near North Diversion Channel and Masthead

Two examples of structural BMPs for gross pollutant removal are shown in Figures 8 and 9. Preliminary cost estimates are based on these concepts. In Figure 9, a photograph of an existing AMAFCA structure, water passes under a concrete baffle wall and then over a sloped screen, allowing accumulation and storage of gross pollutants while allowing water and particulates less than the screen spacing size to pass through. Such a structure requires good access for a crew of workers or a vacuum truck, along with a dump truck for disposal of waste.

The structures shown in Figures 8 and 9 can be cleaned out either manually or using equipment. Nets can be maintained using a boom truck without direct vehicular access to the outfall. Netting requires removal and replacement during routine maintenance in order to dispose of captured floatables, as well as replacement when damaged.

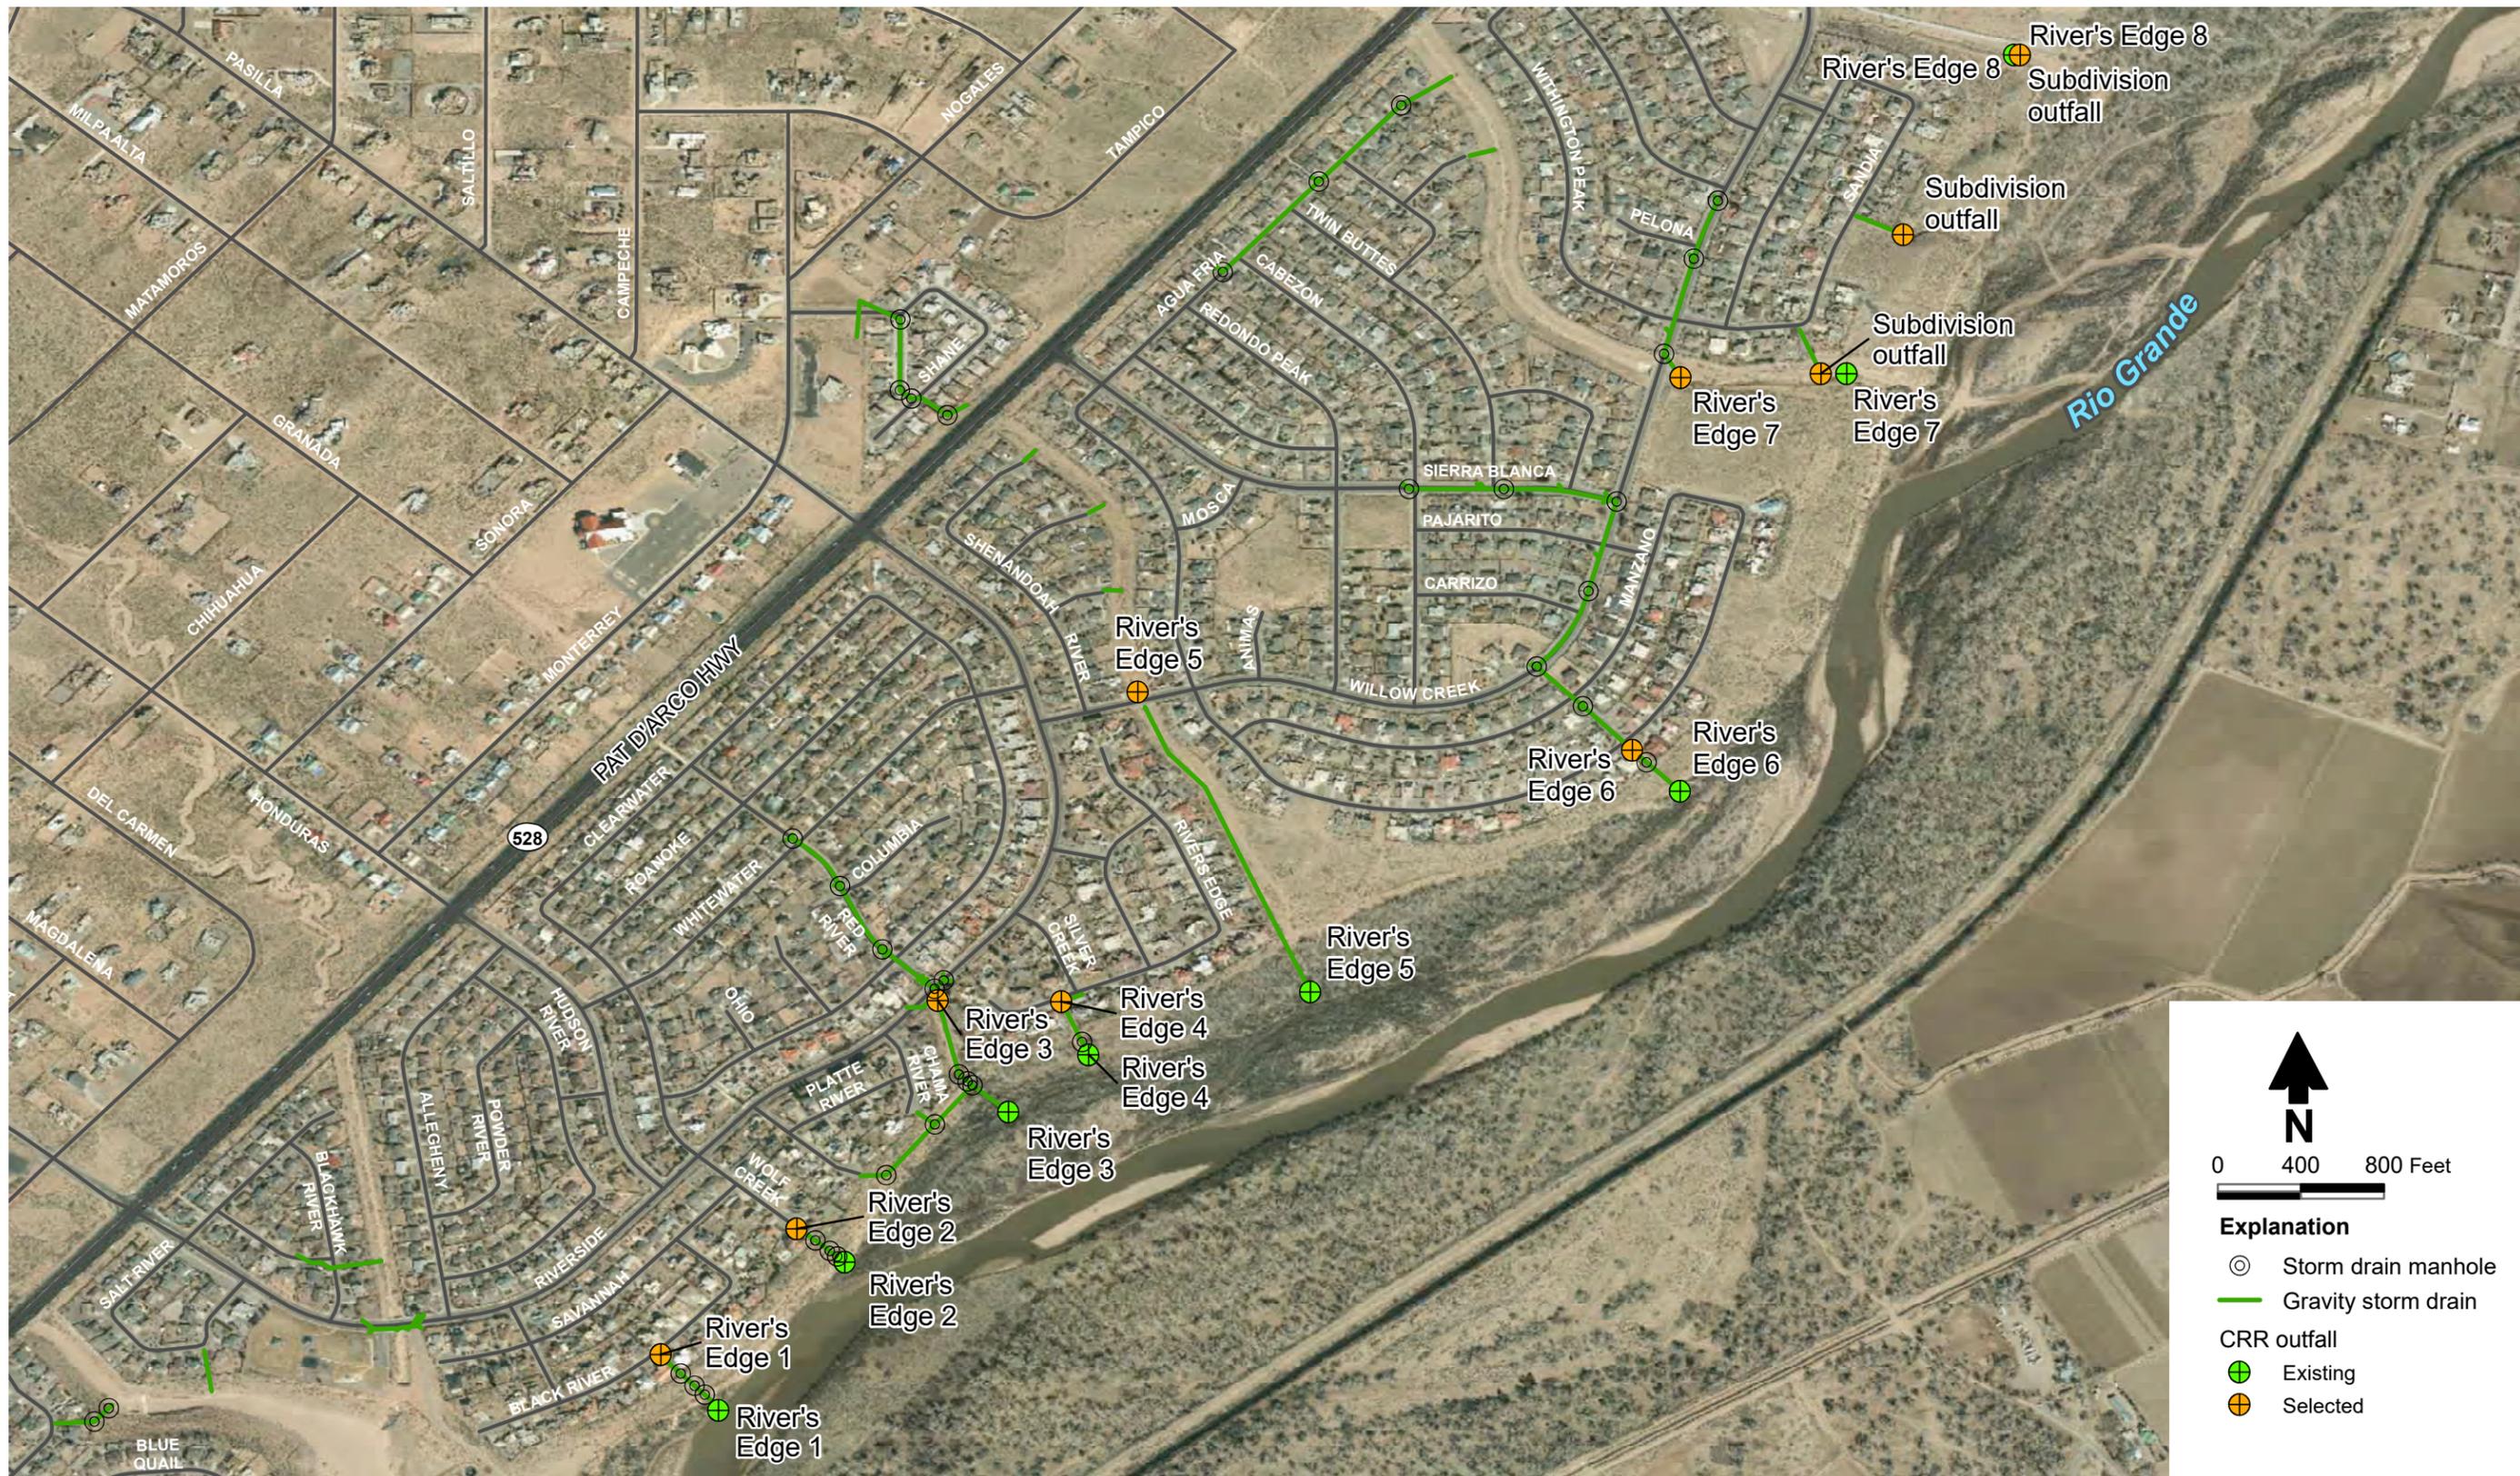
Table 6 summarizes the evaluation of options for each outfall. Figure 10 shows the locations selected for improvements associated with each outfall. Due to lack of access for construction and ongoing maintenance, only one recommended location is at the actual outfall. Inlet improvements and manhole separators will provide access from existing roadways. Improvements within the channels are recommended for RE5, RE7, and RE8. Recommendations are detailed in Section 5, including estimated capital and O&M costs.

Table 7 summarizes the recommended options for each outfall, with preliminary estimated capital and annual O&M costs. Detailed cost estimates are provided in Appendix B. Figure 10 shows the location of the options, along with the location of each outfall.

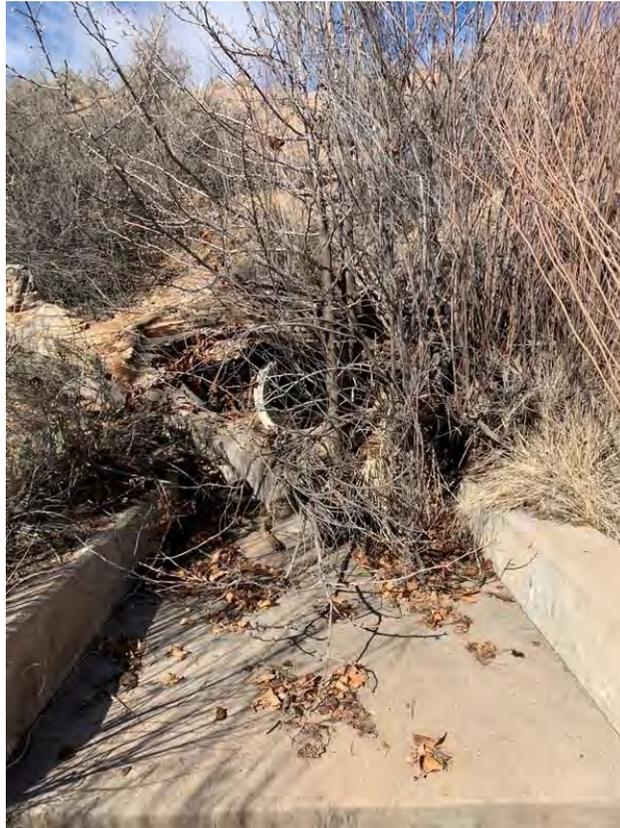
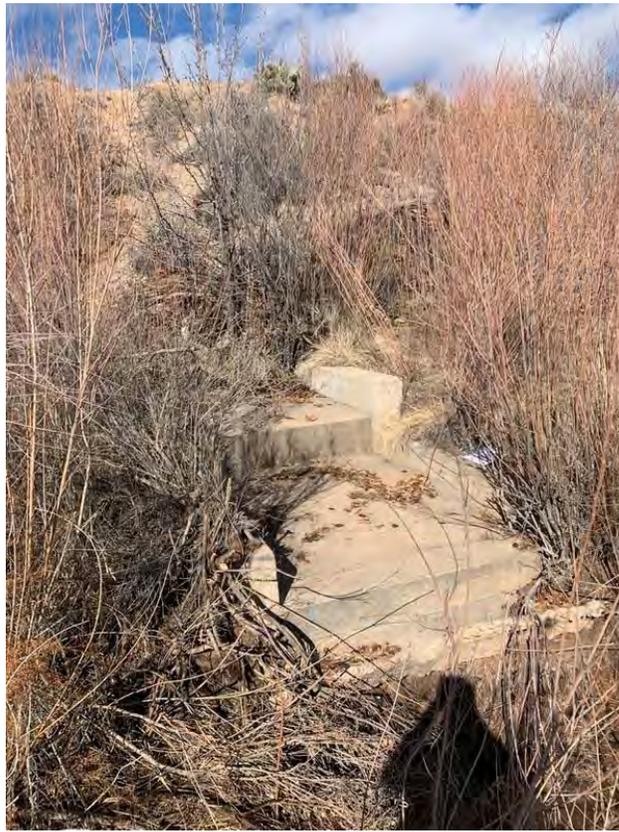
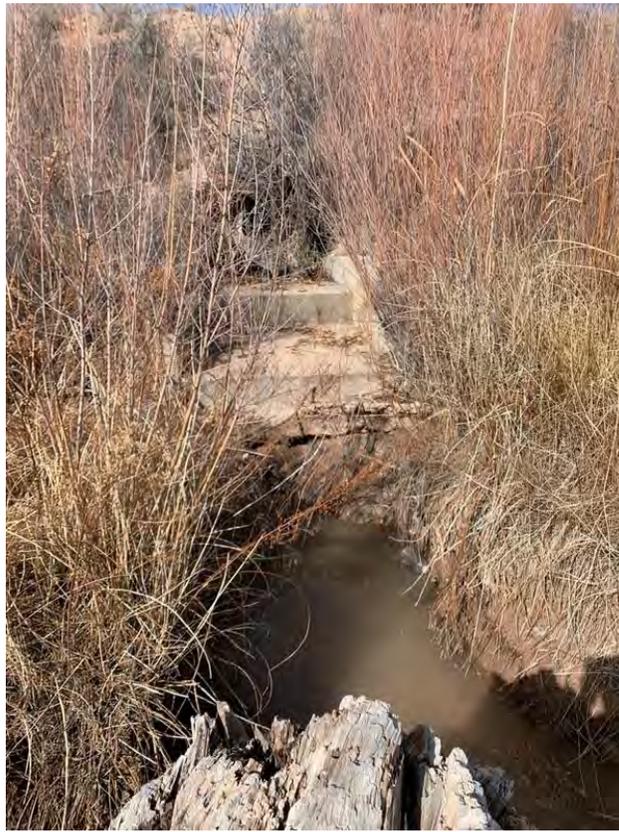
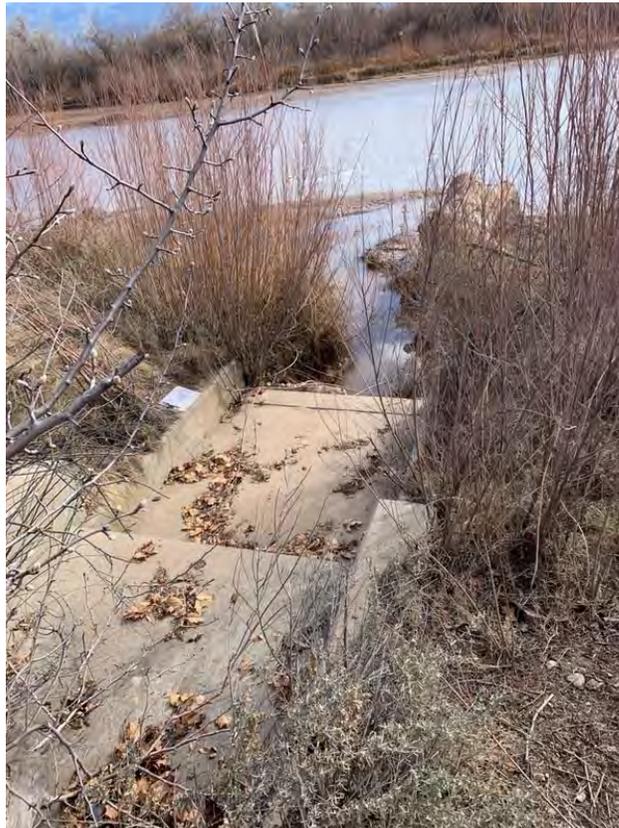
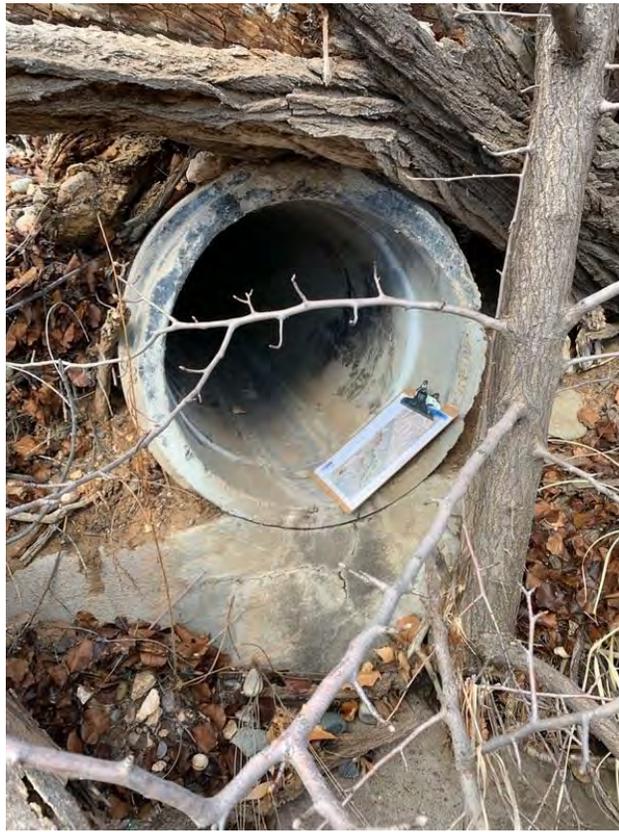
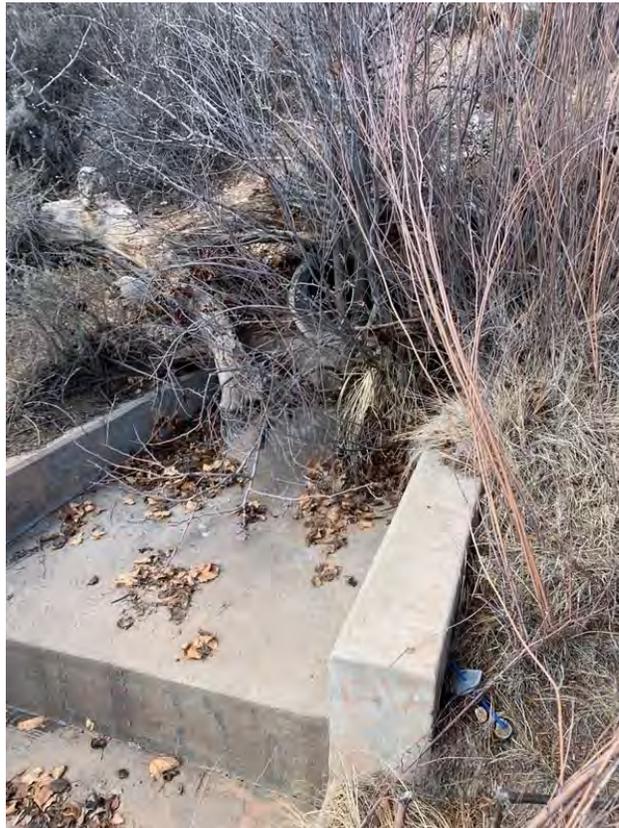
Created	2019-01-16 18:40:23 UTC by Omar Ruiz
Updated	2019-01-16 21:06:54 UTC by Omar Ruiz
Location	35.2850410005954, -106.596708899708
Outfall	Rivers Edge 1
Visible Outfall	Yes
Date	2019-01-16
Time	11:40
Photos

Outfall has plenty of space for storm water treatment. Heavy vegetation. Water drains into small pond before draining into river. No visible trash.

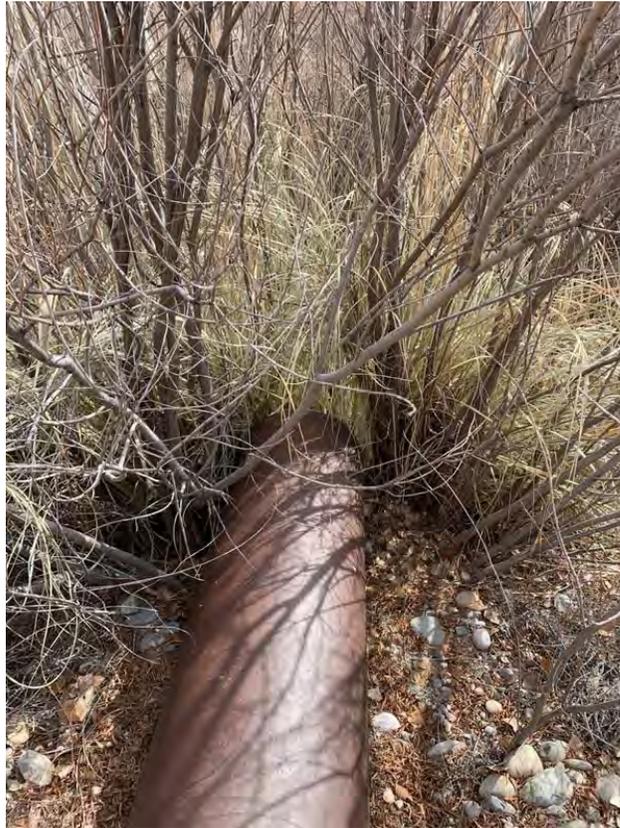
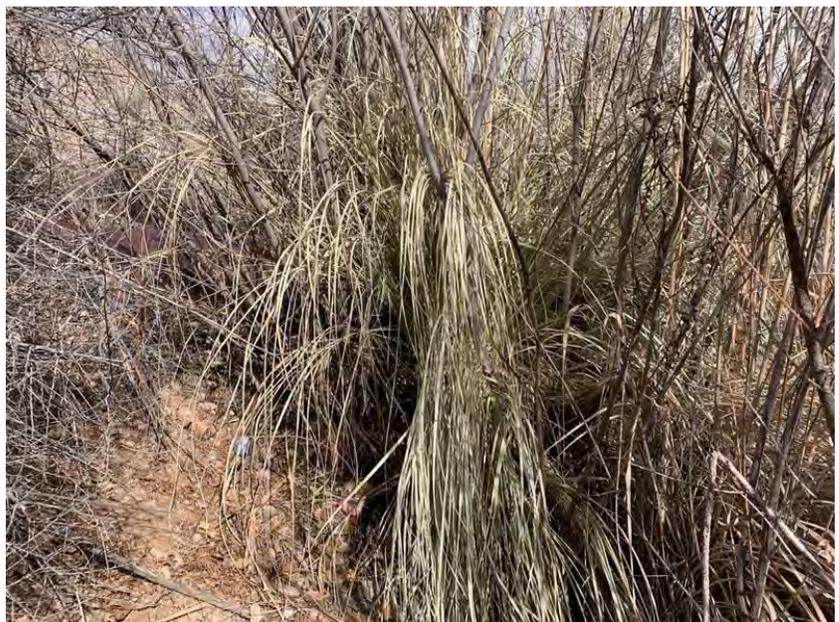
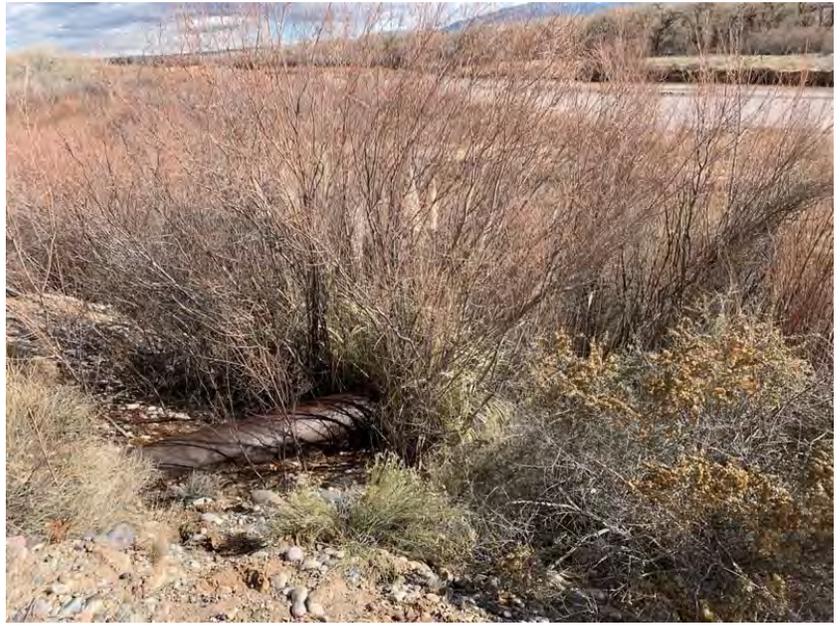
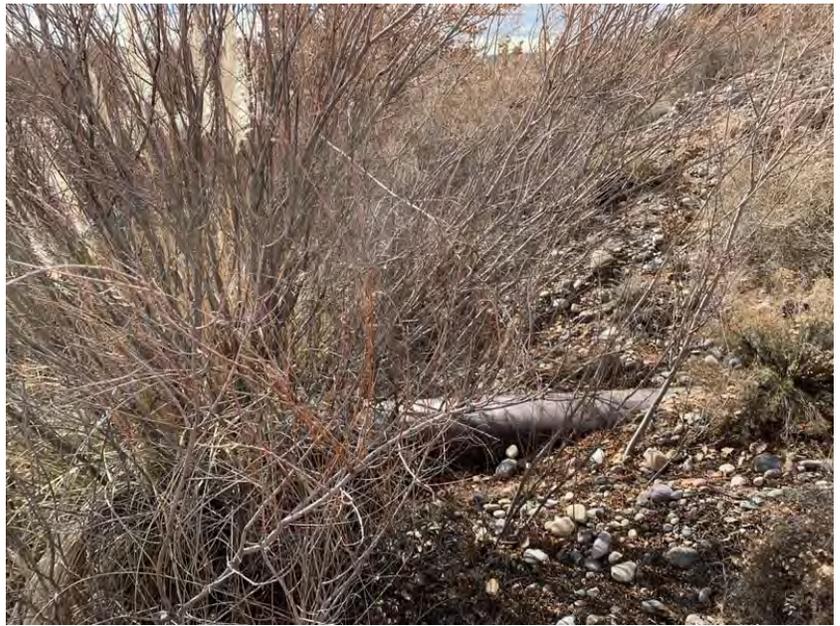
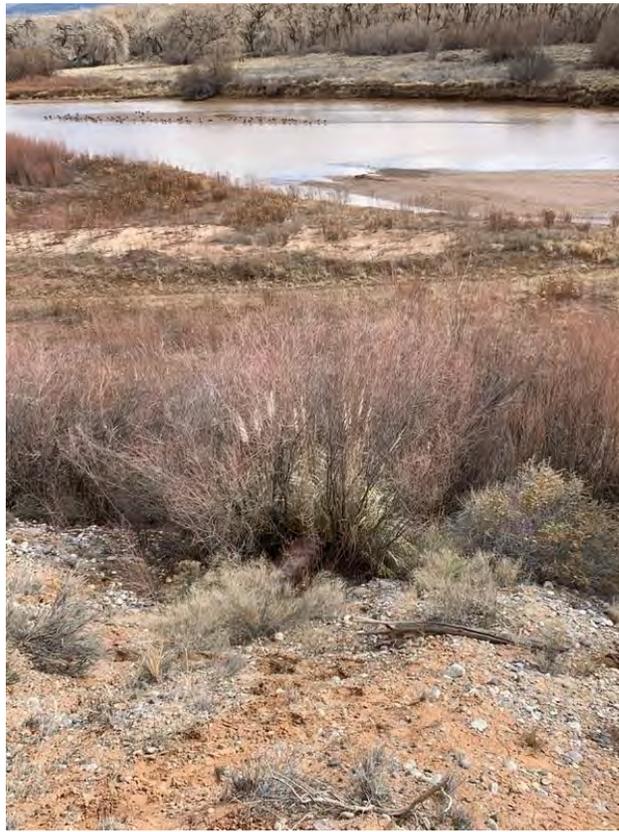
Created	2019-01-16 19:11:23 UTC by Omar Ruiz
Updated	2019-01-16 21:05:20 UTC by Omar Ruiz
Location	35.2869029422585, -106.594983142809
Outfall	Rivers Edge 2
Visible Outfall	No
Date	2019-01-16
Time	12:11
Photos

Heavy vegetation at the pipes outfall. Steep hill west of outfall. Light trash. Invert of pipe is above downstream surface elevation. Water ponds in river bank.

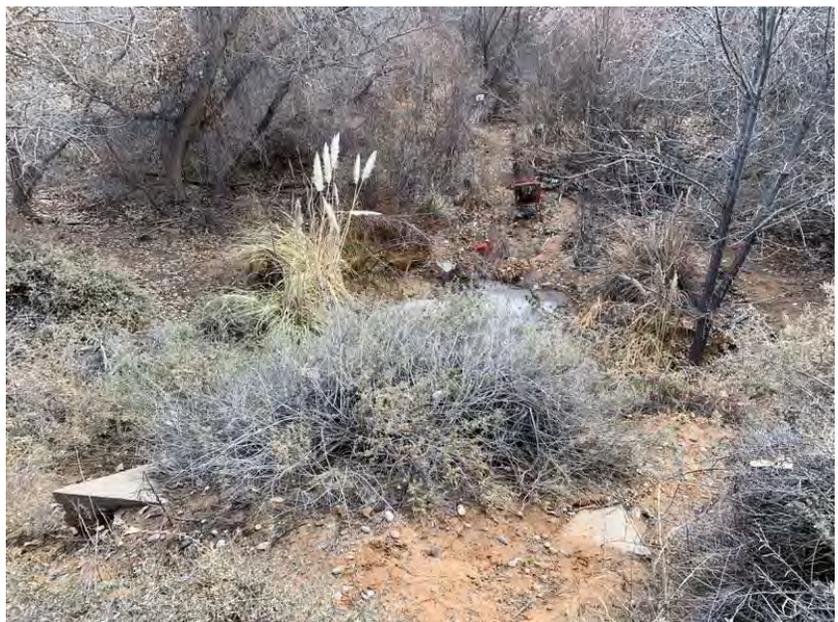
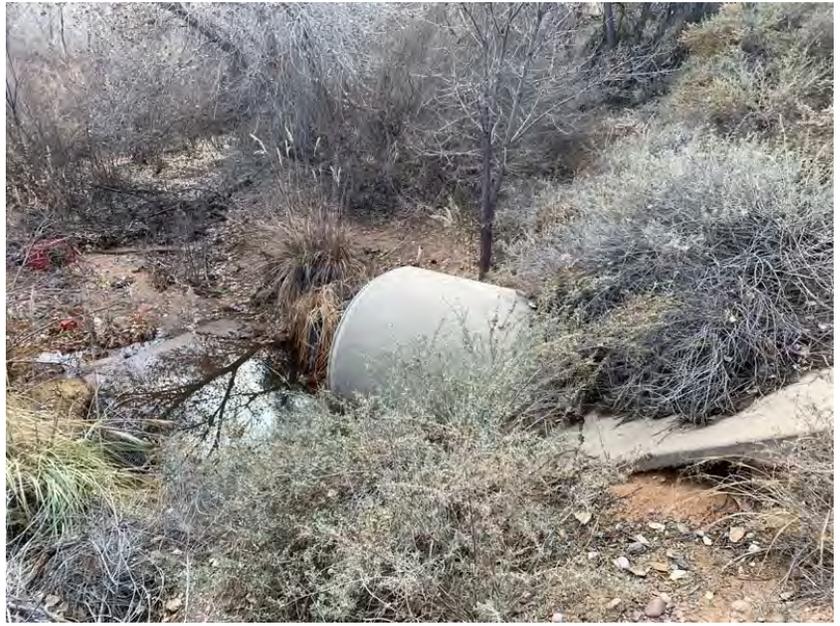
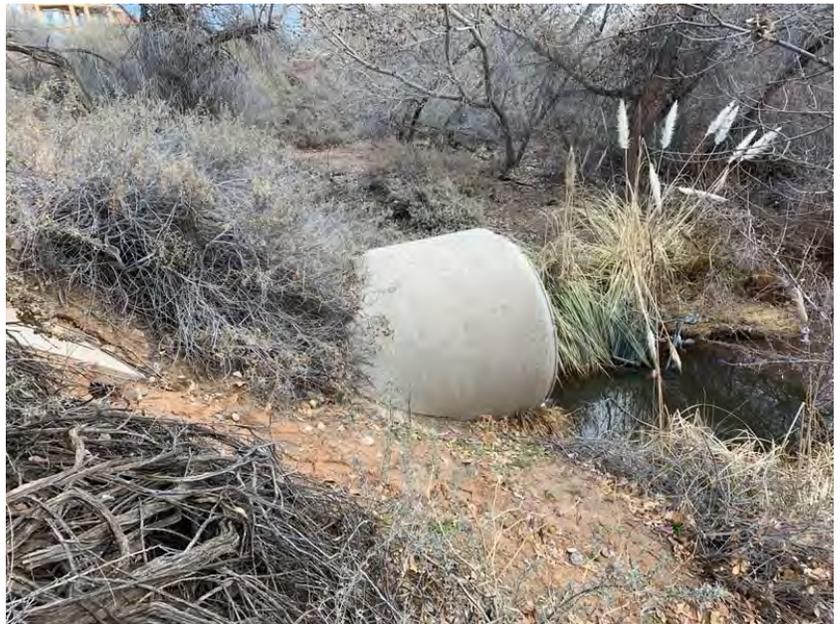
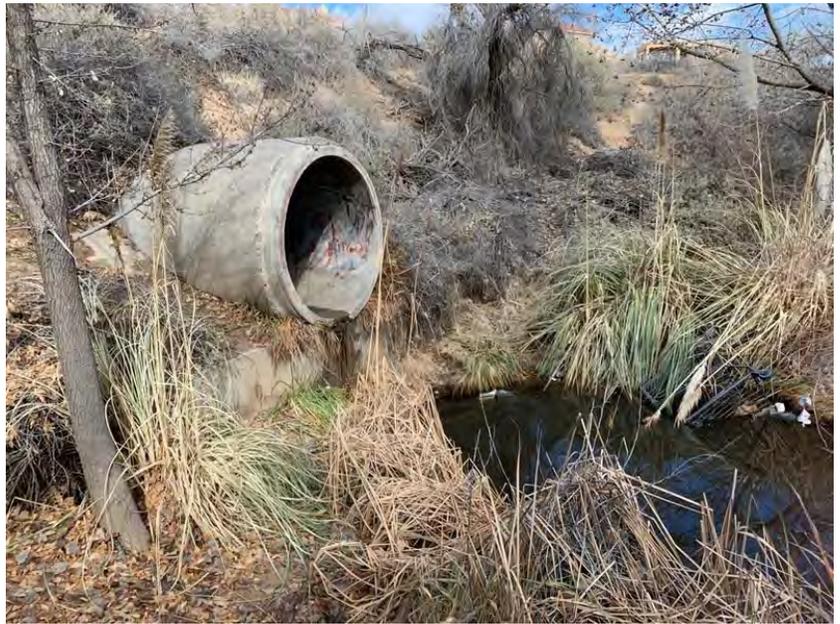
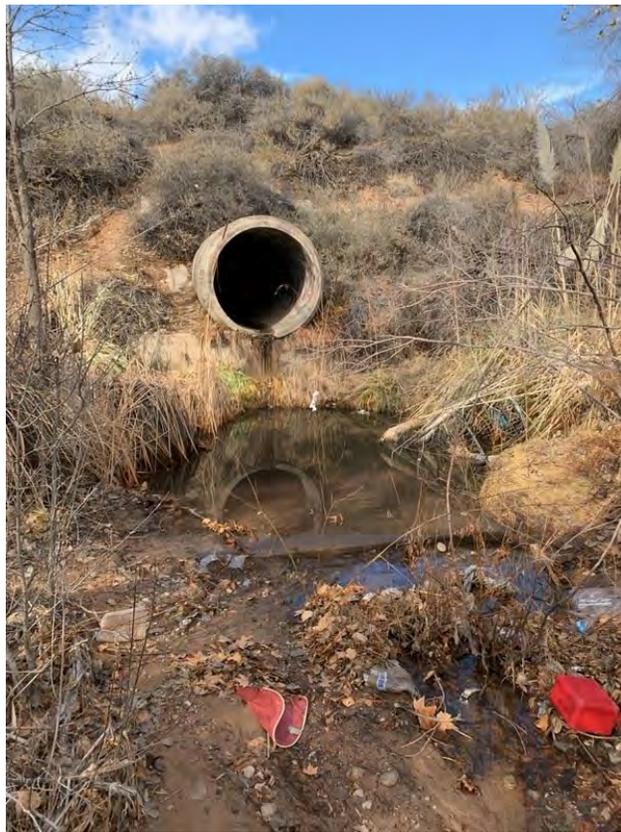
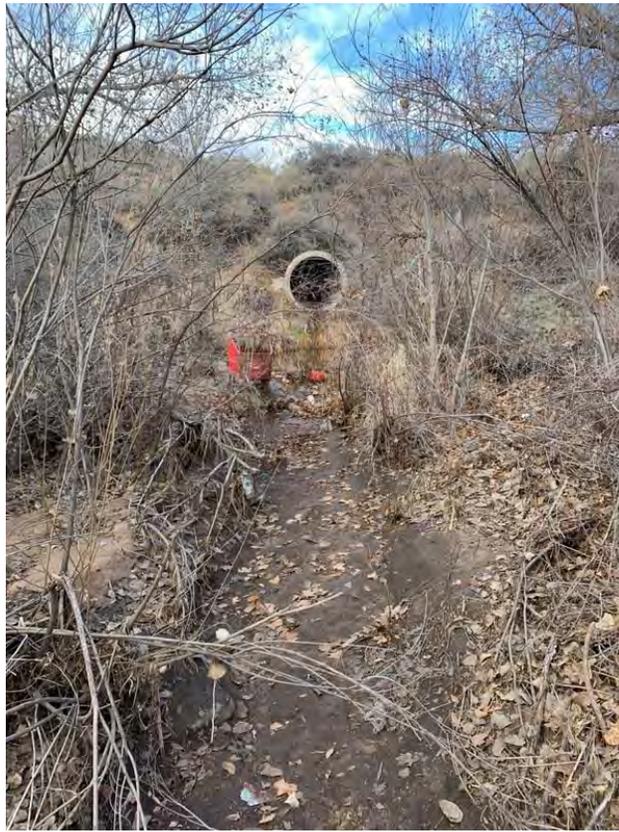
Created	2019-01-16 19:31:45 UTC by Omar Ruiz
Updated	2019-01-16 19:36:12 UTC by Omar Ruiz
Location	35.2892459734797, -106.593187744294
Outfall	Rivers Edge 3
Visible Outfall	Yes
Date	2019-01-16
Time	12:31
Photos

Plenty of room for storm water treatment. Location was full of trash. Steep hill to the west. Removal of vegetation required.

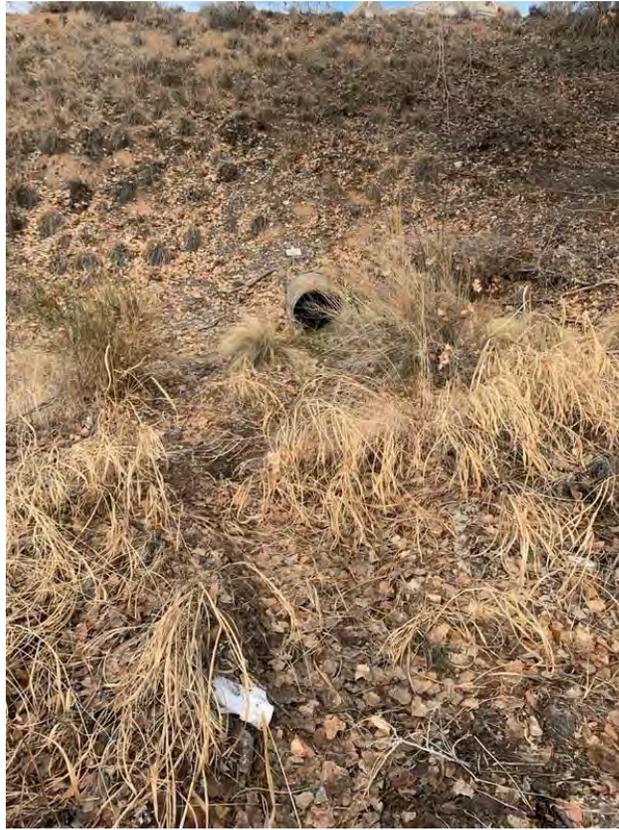
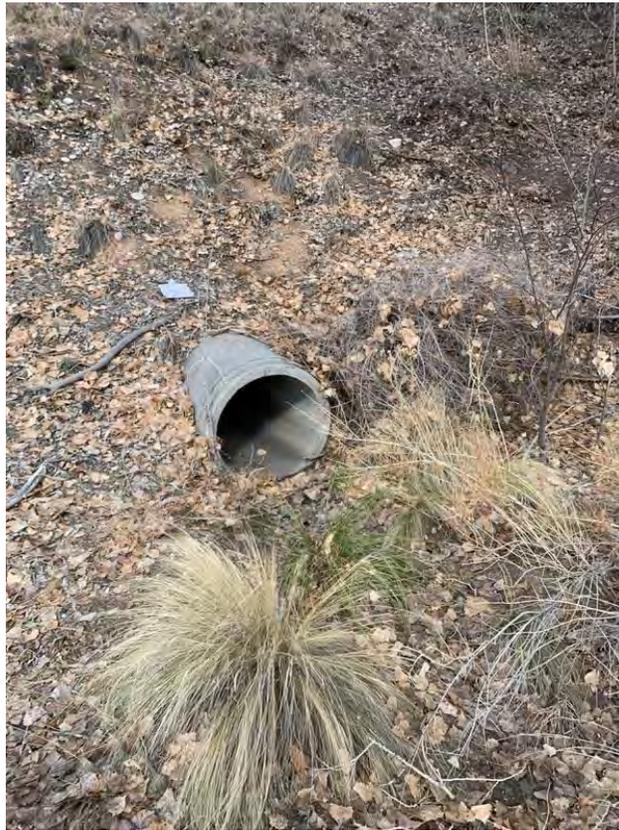
Plenty of space for storm water treatment. Invert elevation of RCP is below downstream surface. Vegetation is light.
