MIDDLE RIO GRANDE WATERSHED BASED MUNICIPAL SEPARATE STORM SEWER (MS4) PERMIT

DRAFT
2018-2019 ANNUAL REPORT
July 1, 2018 – June 30, 2019

Development Services Department
3200 Civic Center Circle NE
Rio Rancho, NM 87144

NPDES GENERAL PERMIT NO. NMR04A000

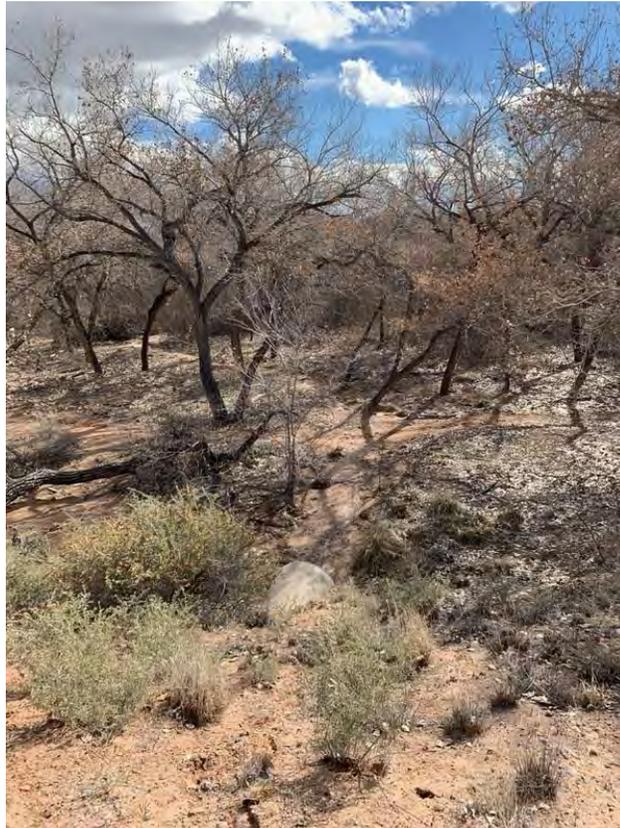
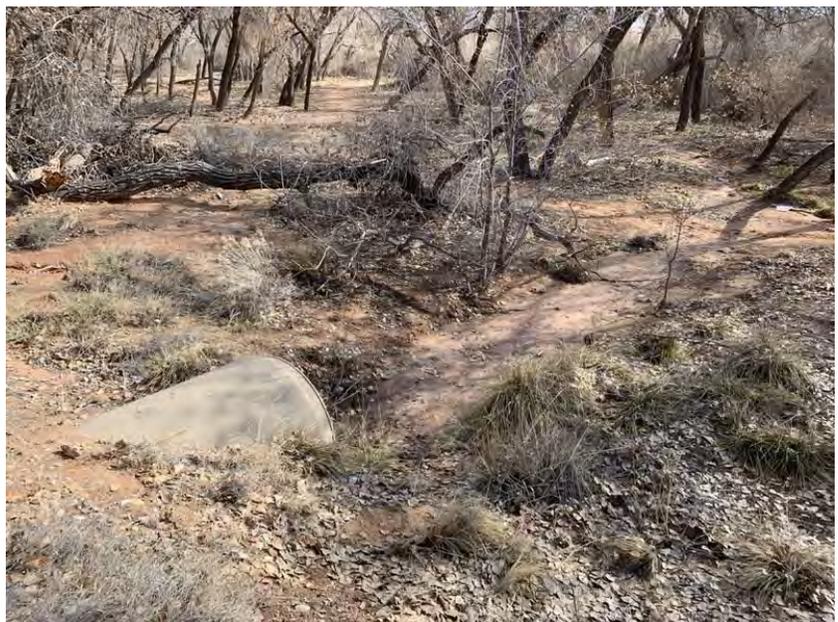
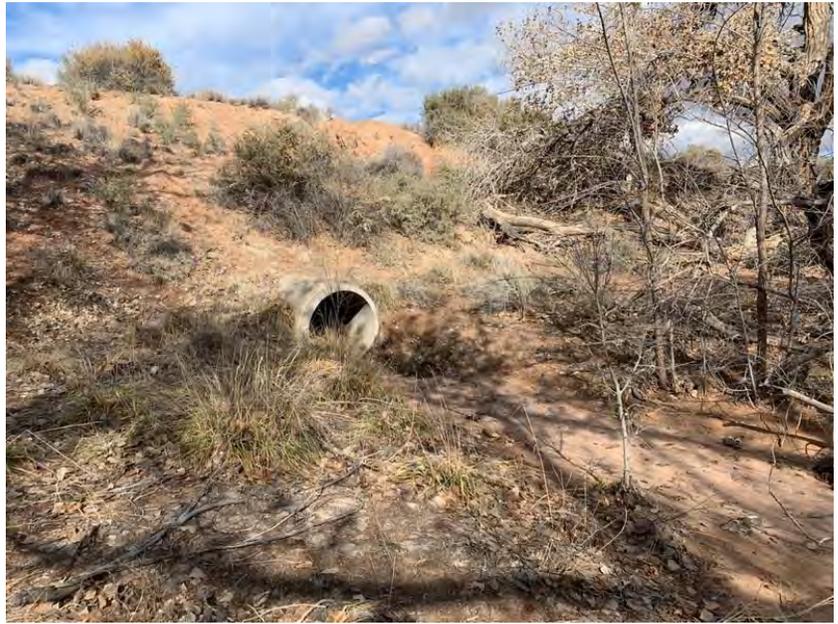
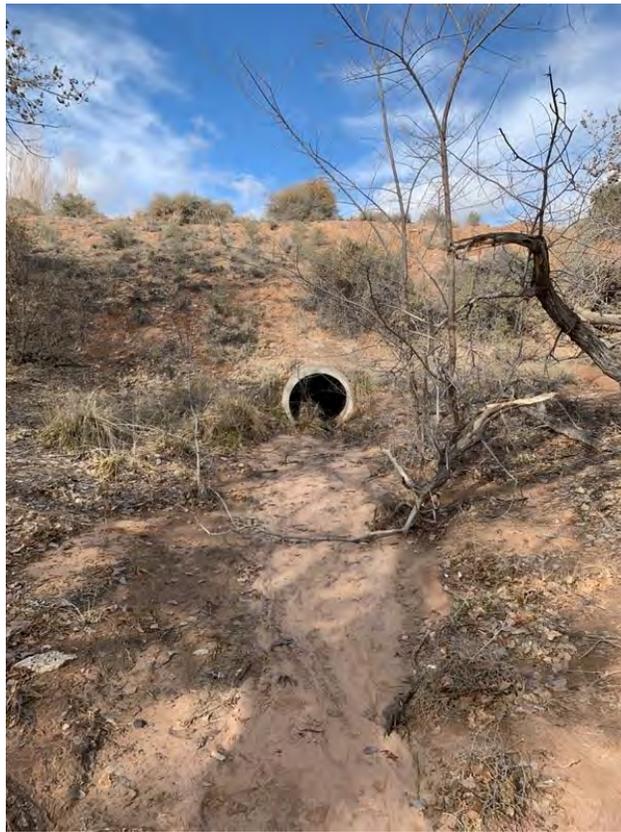
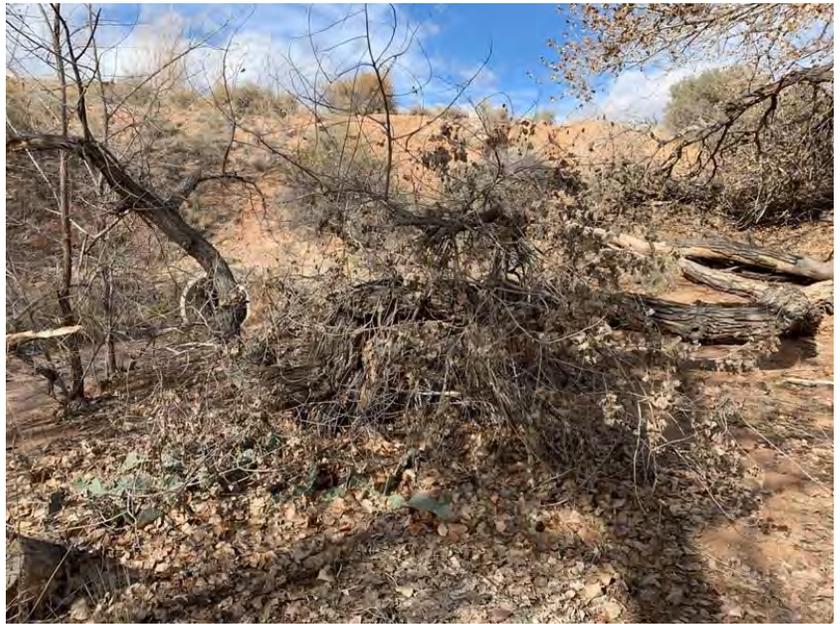
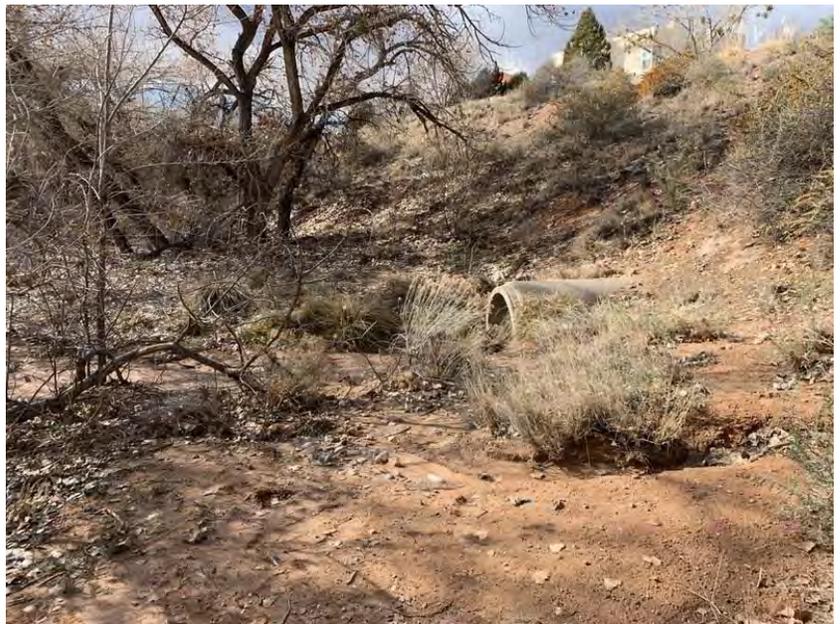
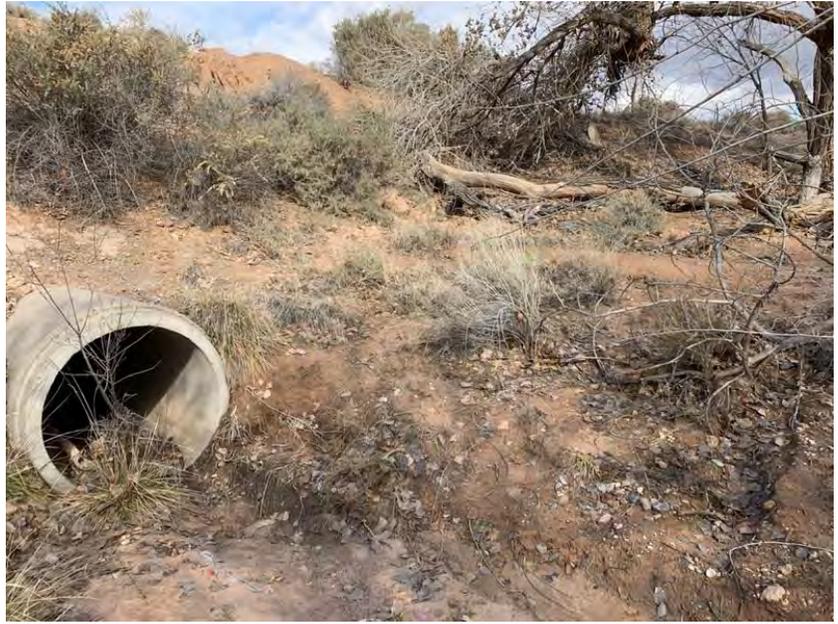
Created	2019-01-16 19:50:29 UTC by Omar Ruiz
Updated	2019-01-16 19:56:23 UTC by Omar Ruiz
Location	35.2909998656331, -106.589052732669
Outfall	Rivers Edge 5
Visible Outfall	Yes
Date	2019-01-16
Time	12:50
Photos

Plenty of space for storm water treatment. RCP invert is below downstream surface elevation. Vegetation is light. Steep hill west of RCP. Light trash. Erosion of hill north west from outfall, water drains just downstream of outfall.

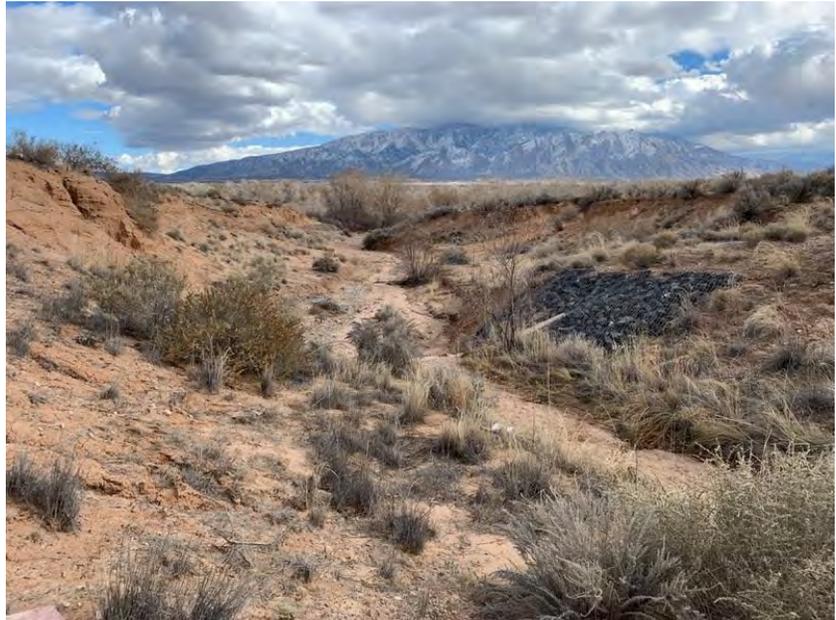
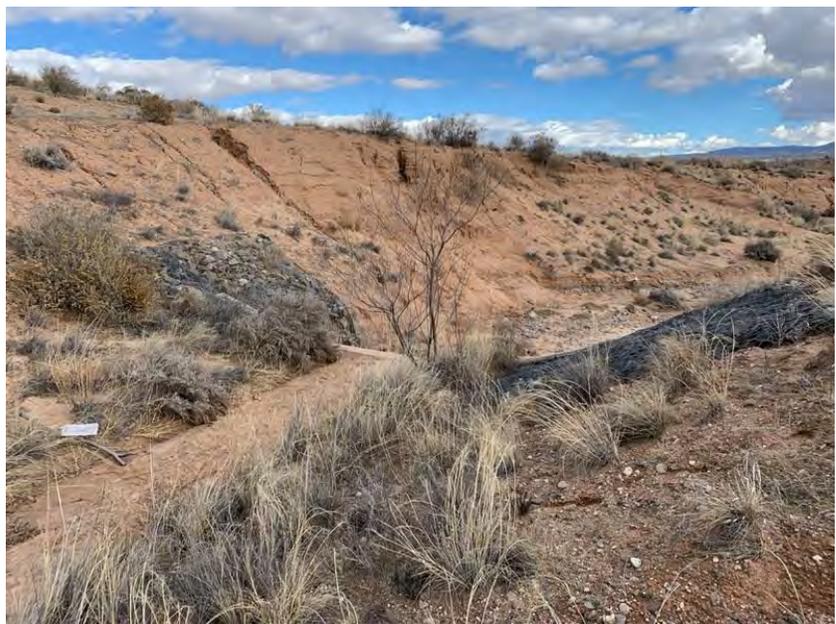
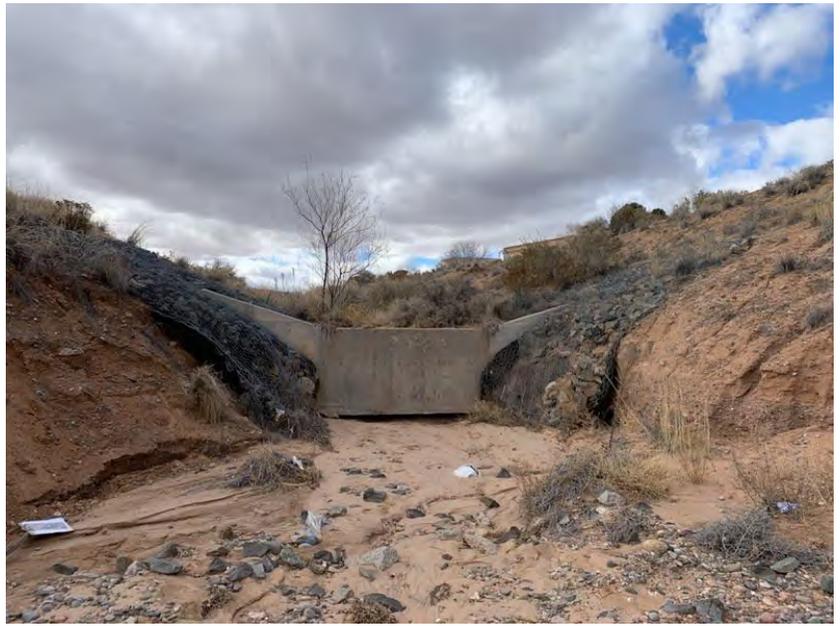
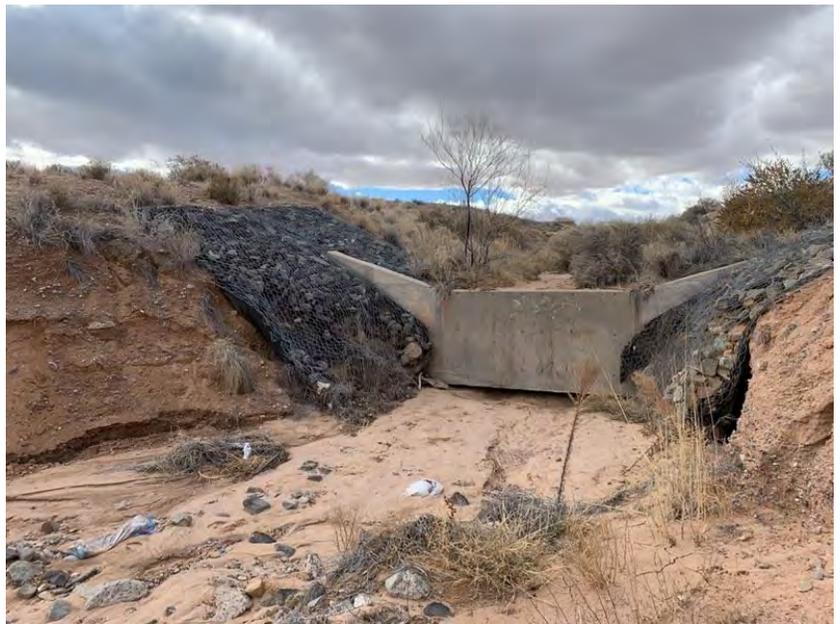
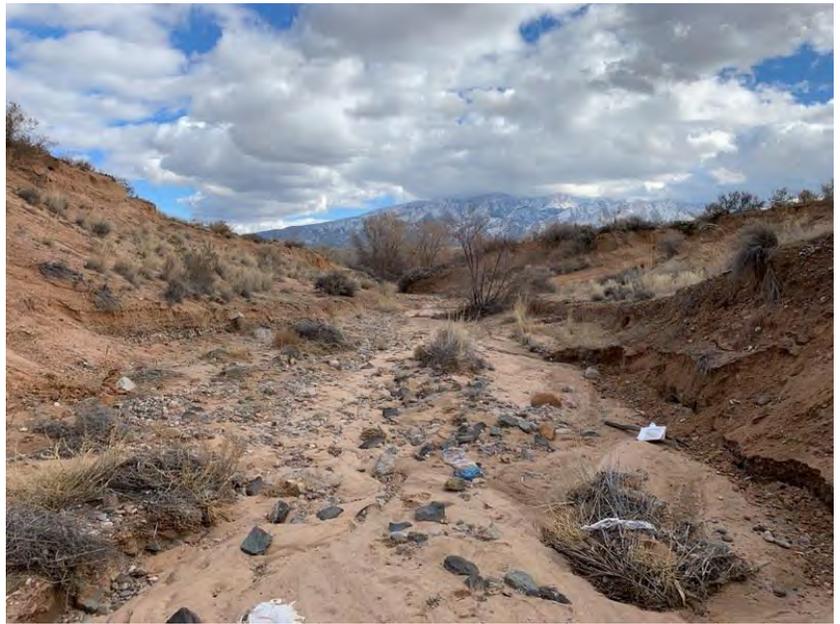
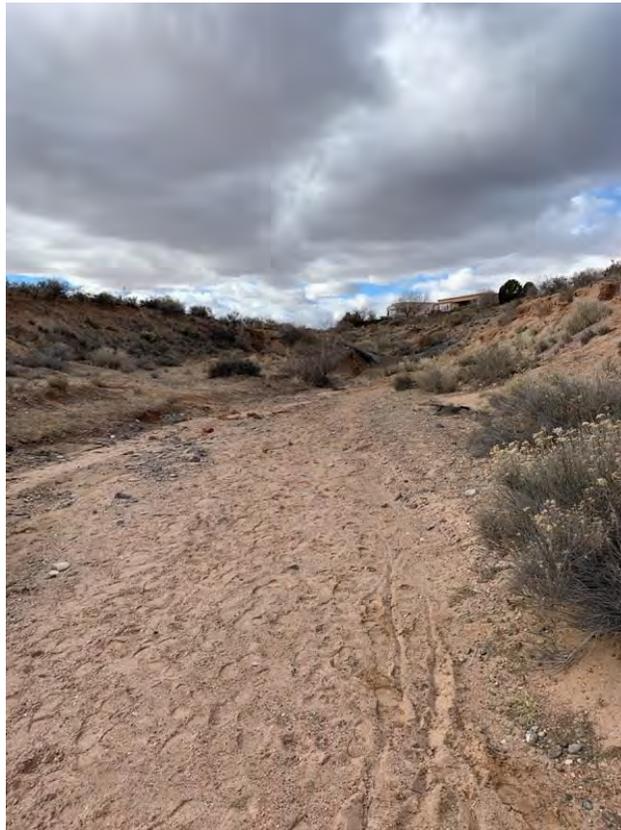
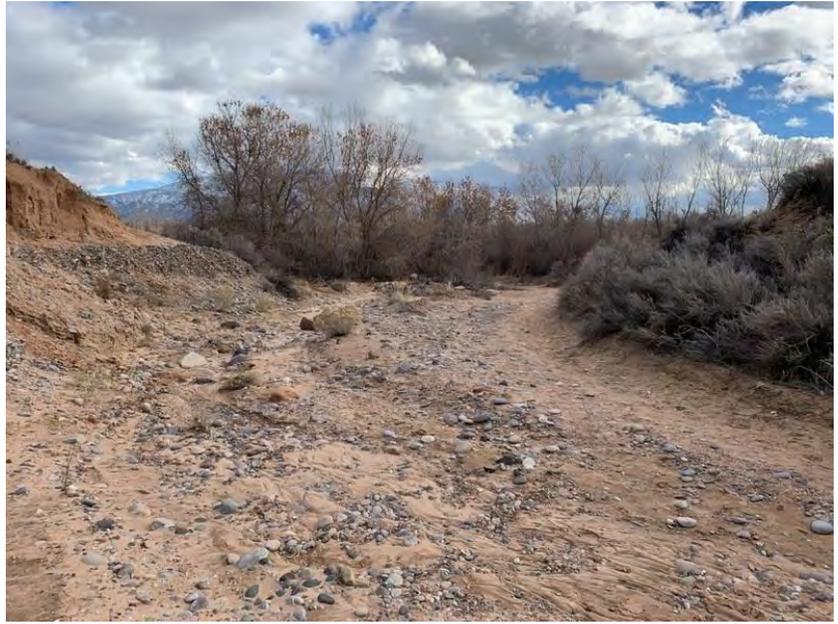
Created	2019-01-16 20:36:26 UTC by Omar Ruiz
Updated	2019-01-16 20:43:21 UTC by Omar Ruiz
Location	35.298617534024, -106.581789492181
Outfall	Rivers Edge 7
Visible Outfall	Yes
Date	2019-01-16
Time	13:36

Water dissipator is located west of river. It has light vegetation no visible trash. Water flows down stream where it ponds at river banks before draining into river.

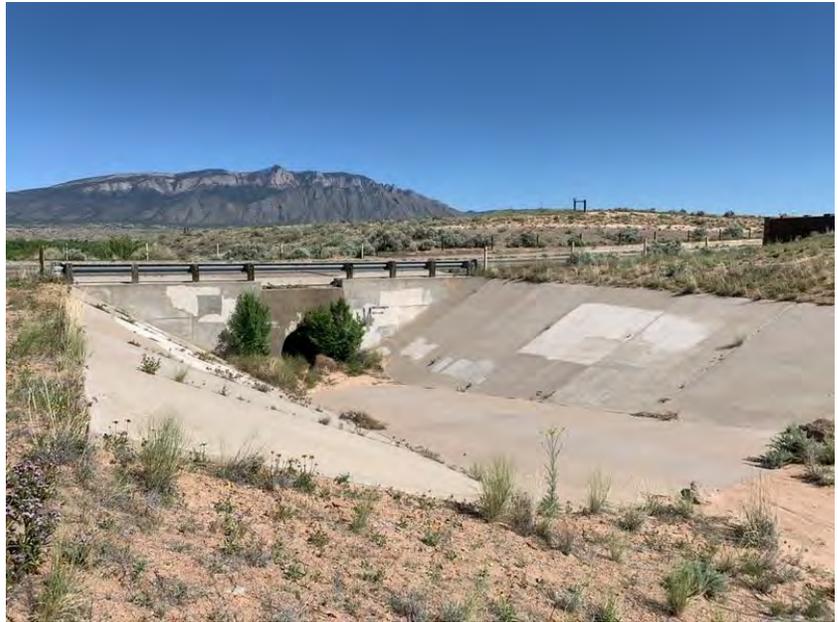
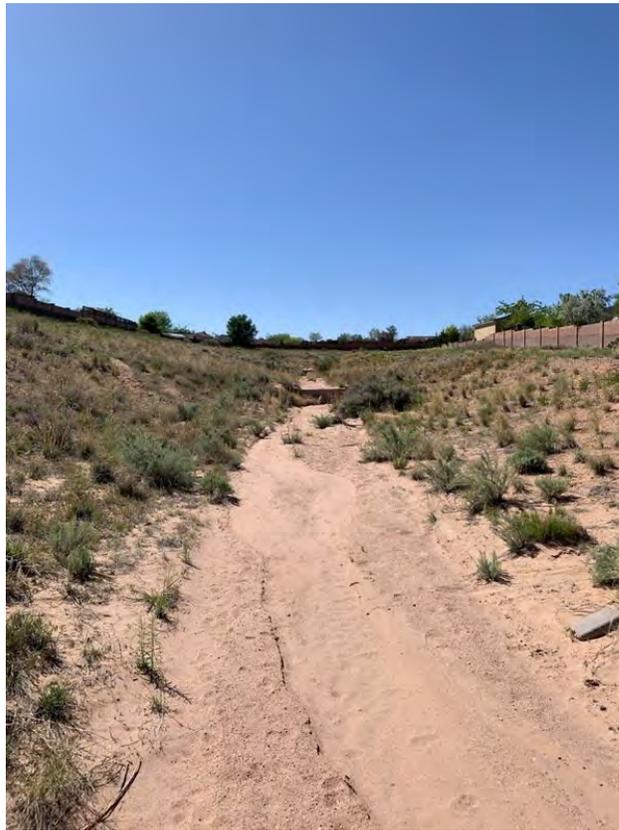
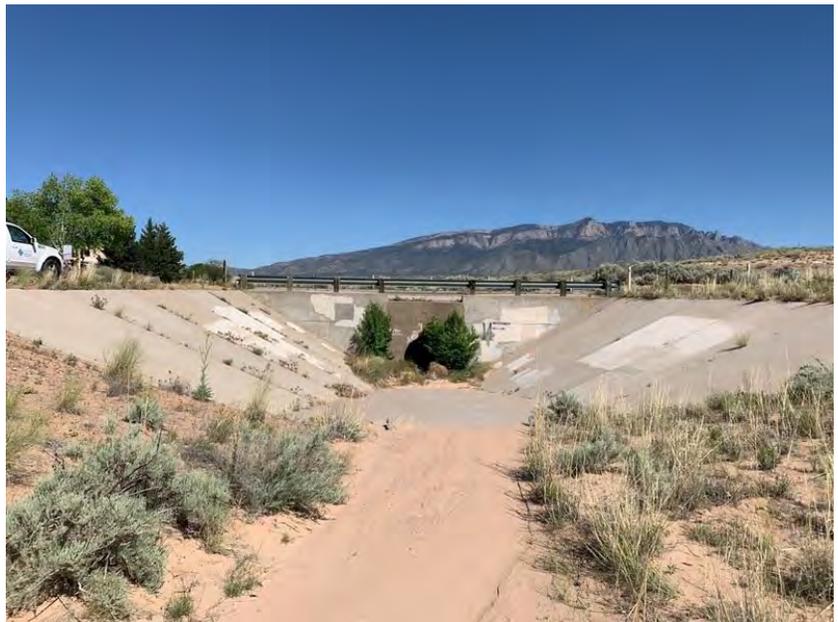
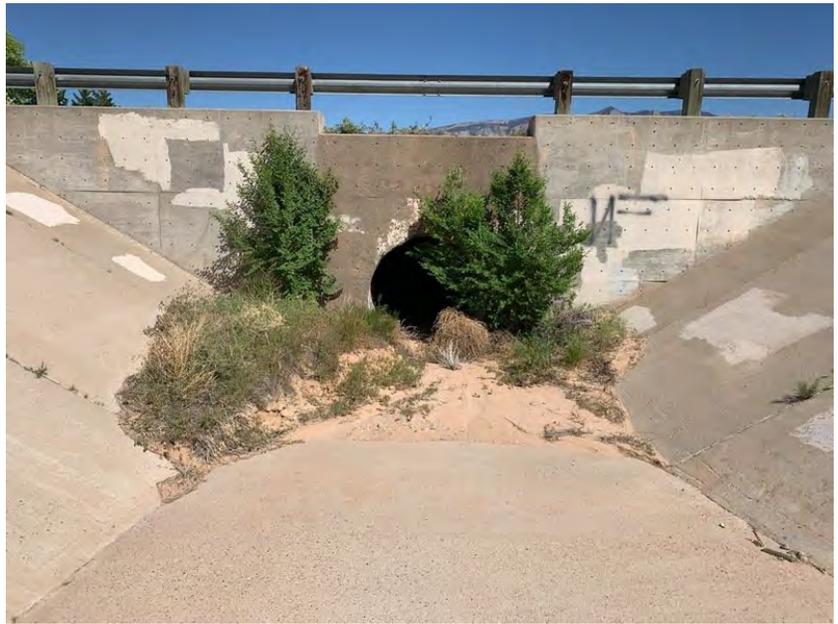
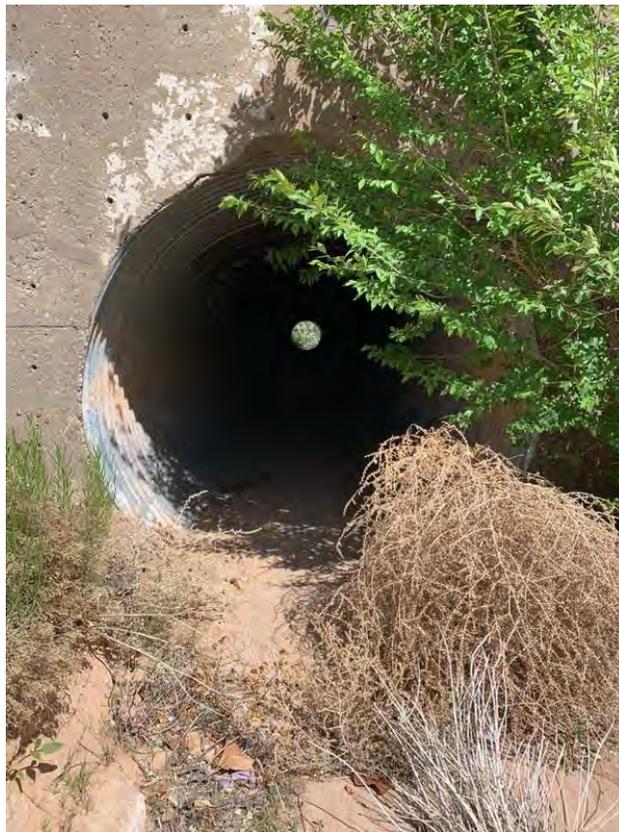
Created	2019-05-03 21:45:49 UTC by Omar Ruiz
Updated	2019-05-13 16:47:31 UTC by Omar Ruiz
Location	35.2988024977, -106.584509628
Status	■ Completed
Outfall	Rivers Edge 7- Inlet
Visible Outfall	Yes
Date	2019-05-03
Time	15:46

Inlet of culvert that leads to outlet.

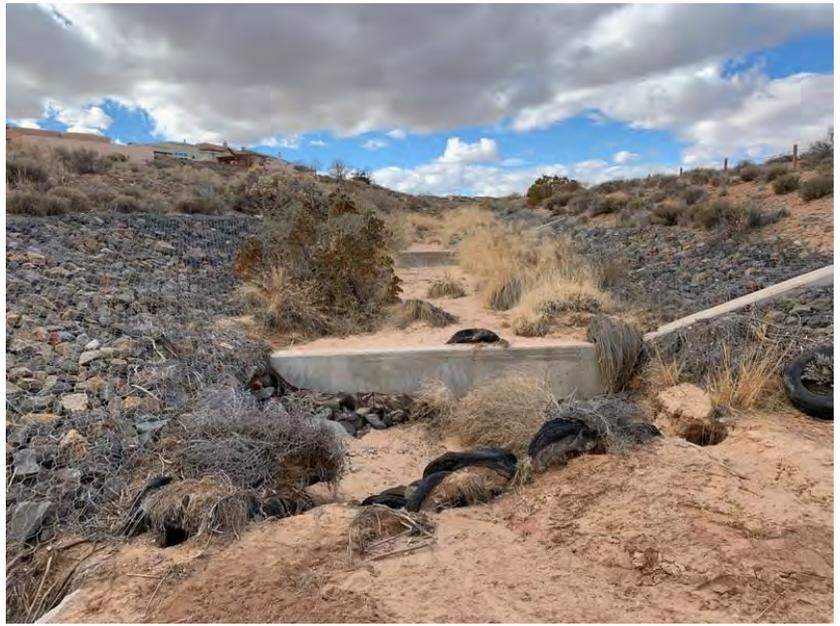
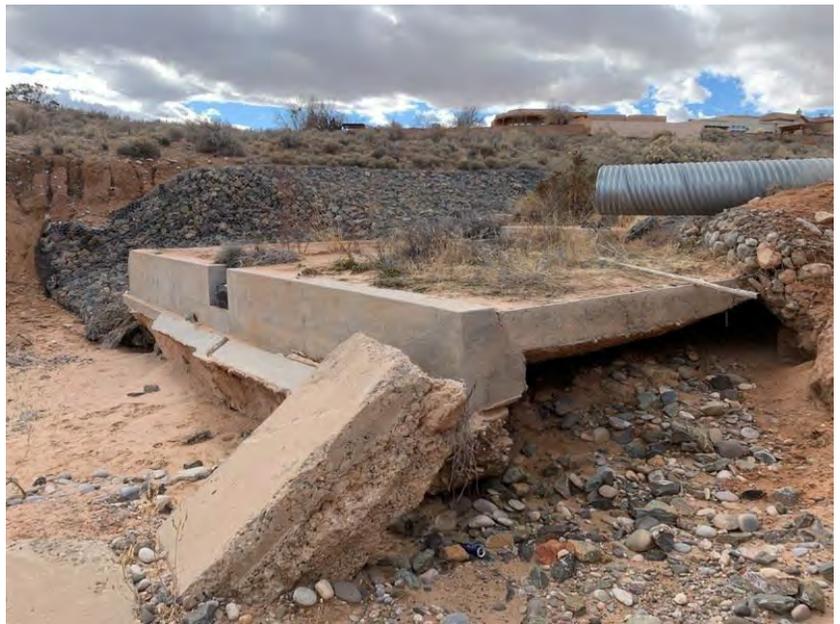
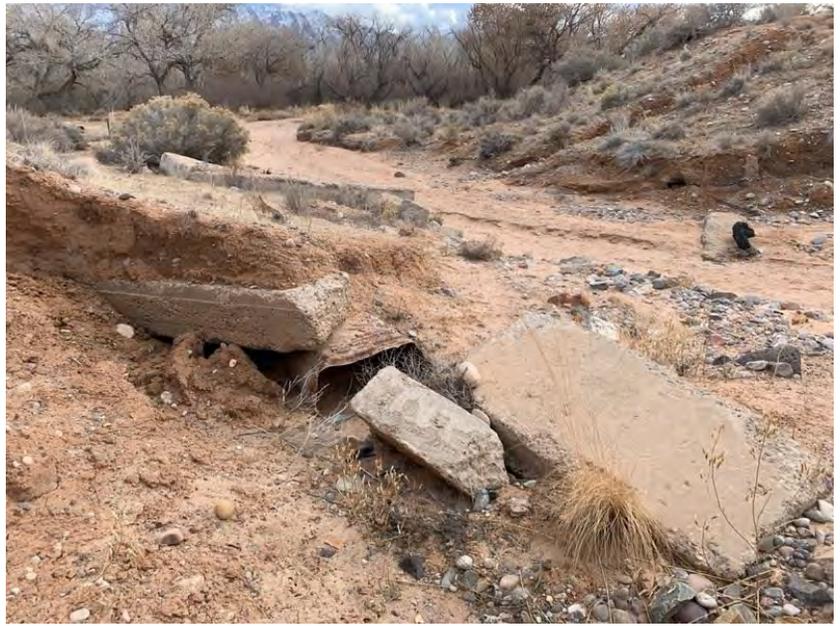
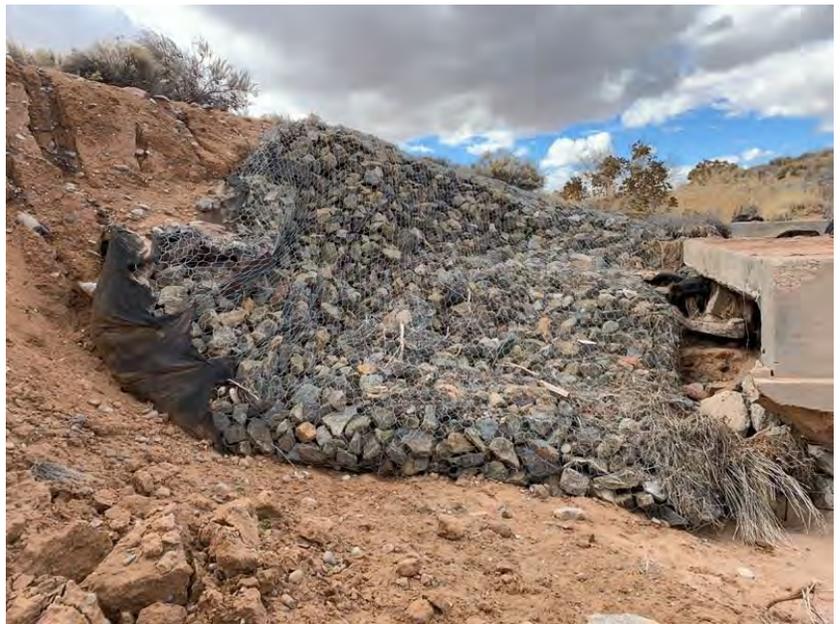
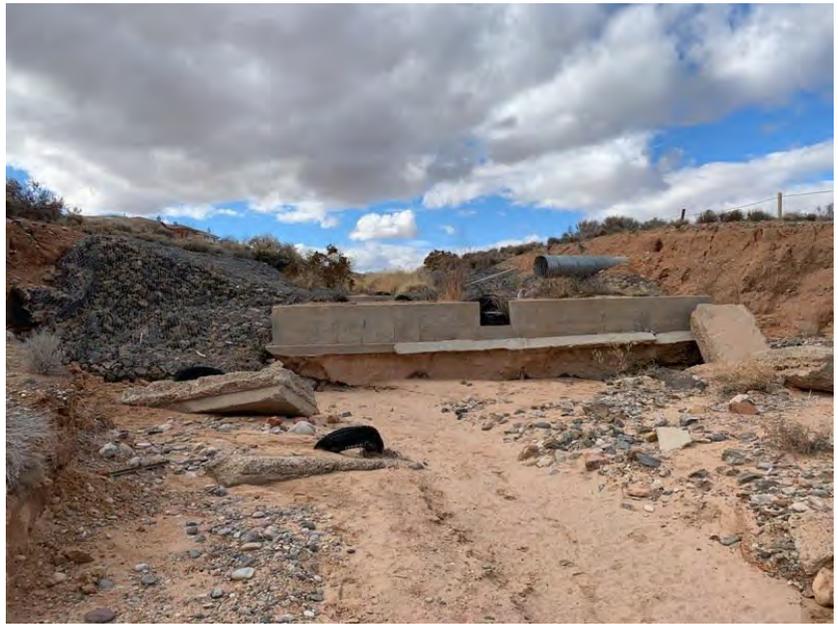
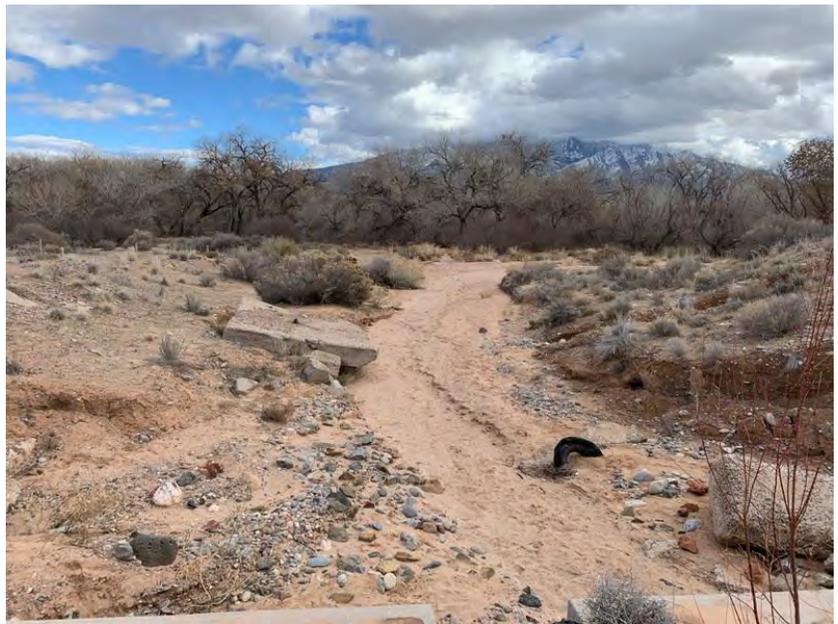
Multiple dissipators upstream. Large structure needs work, currently erosion has removed much of the structures surrounding soil. No visible trash. Vegetation is light. Water ponds in river banks.

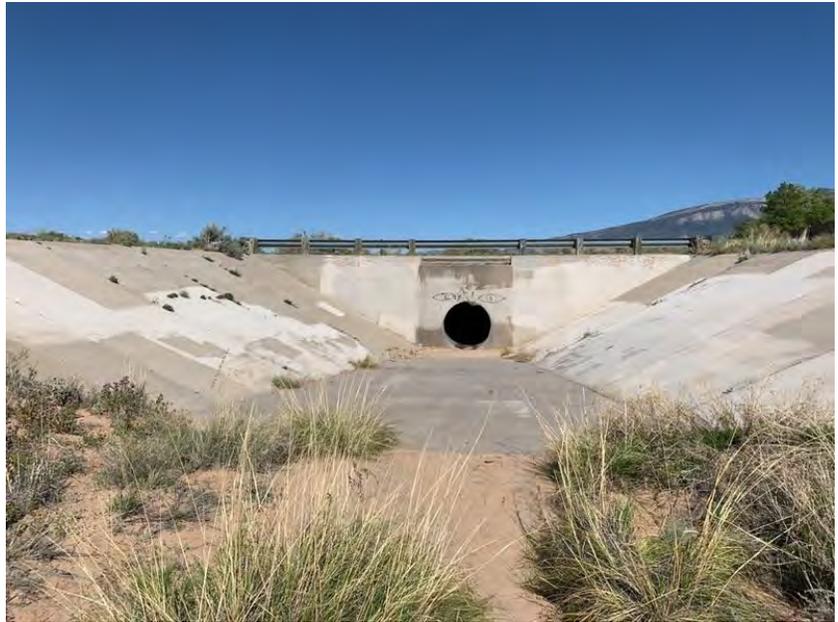
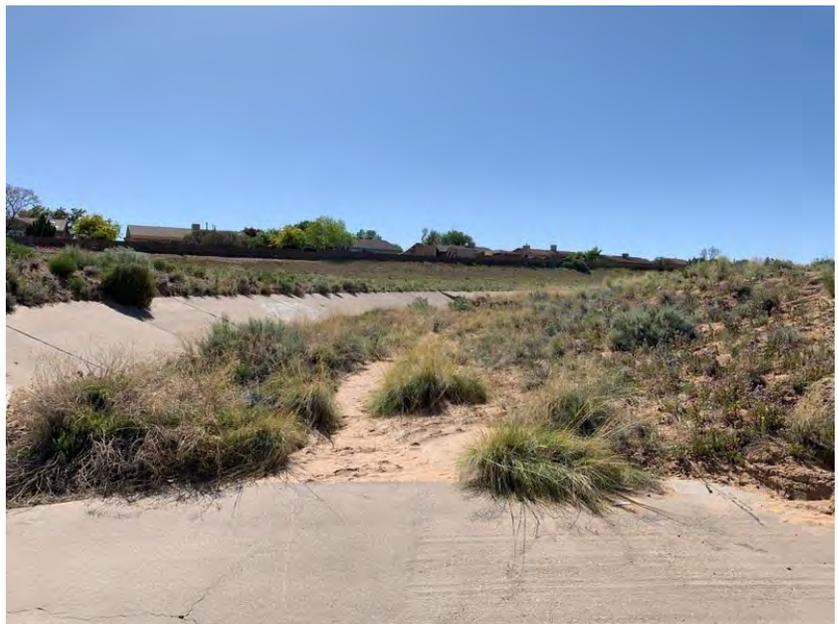
Channel is vegetated

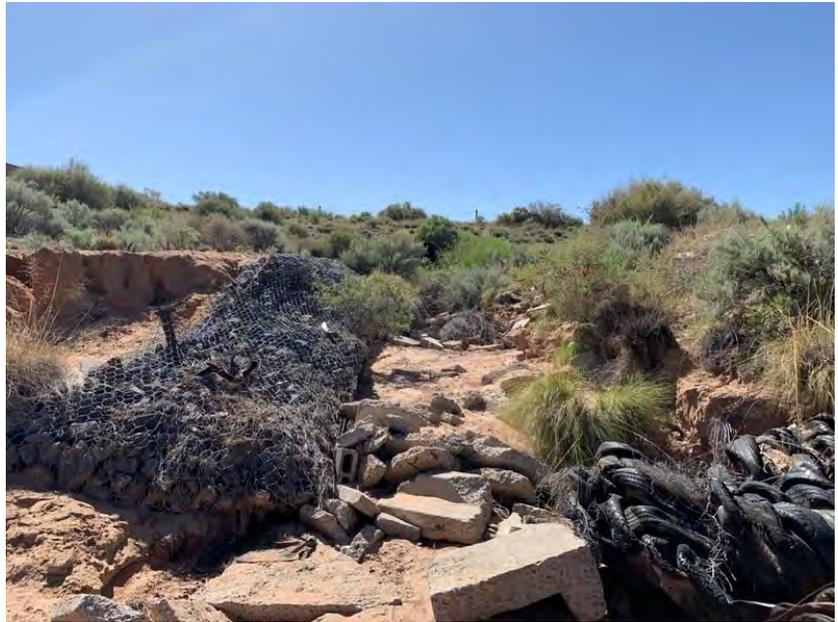
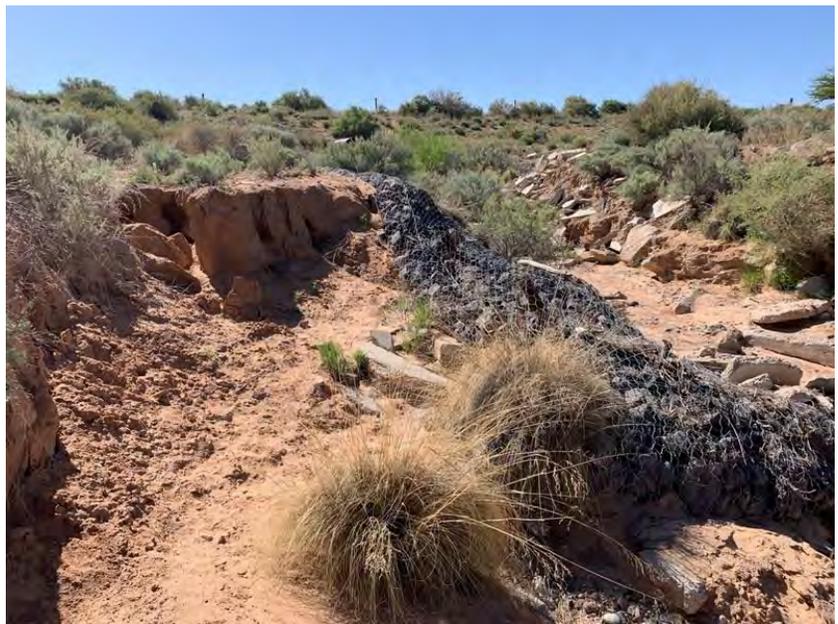
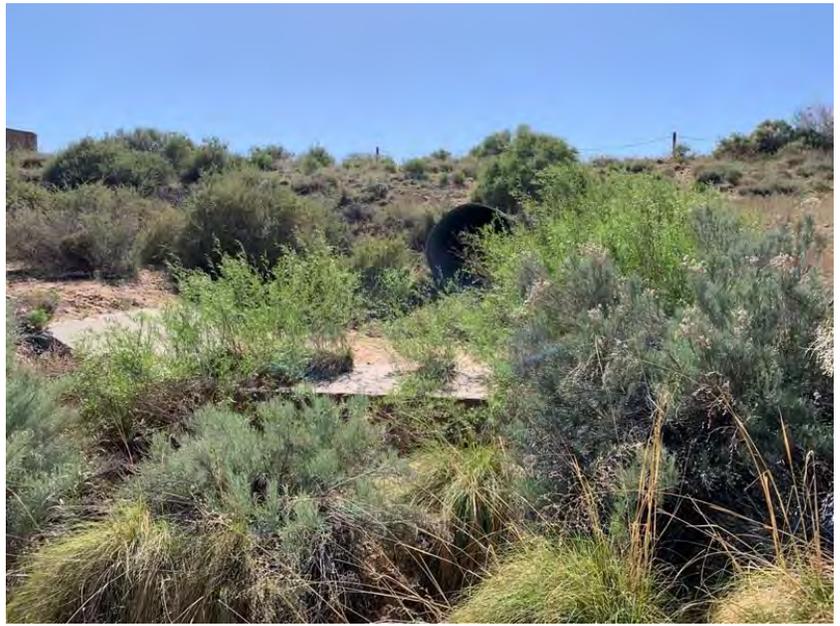
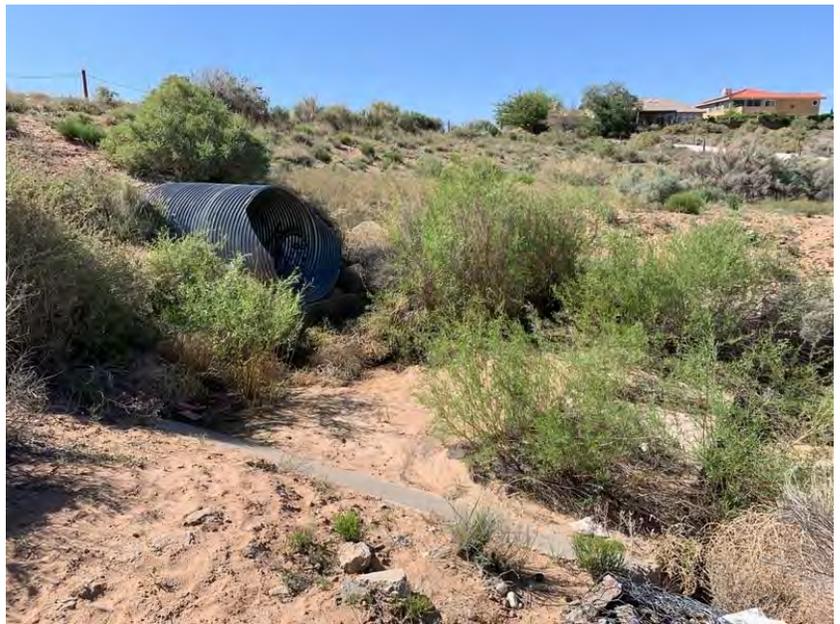
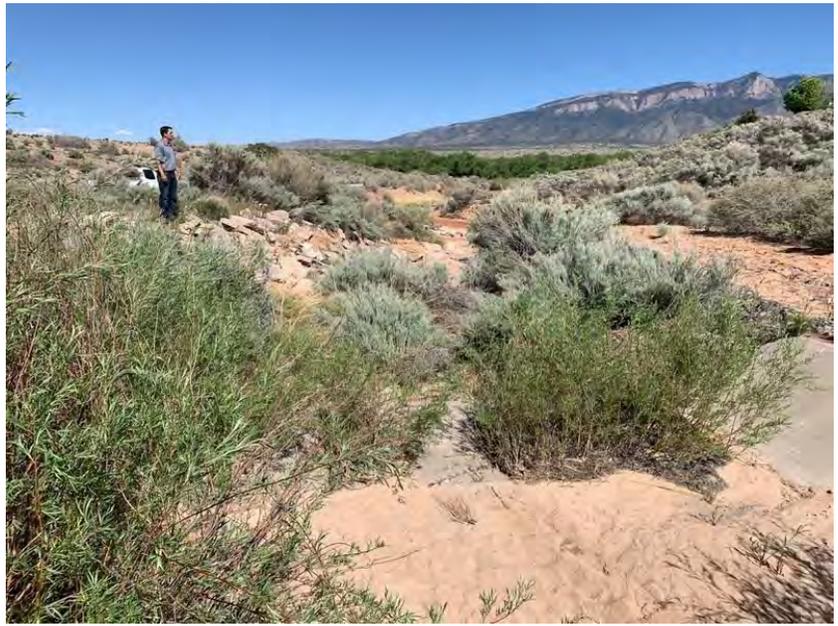
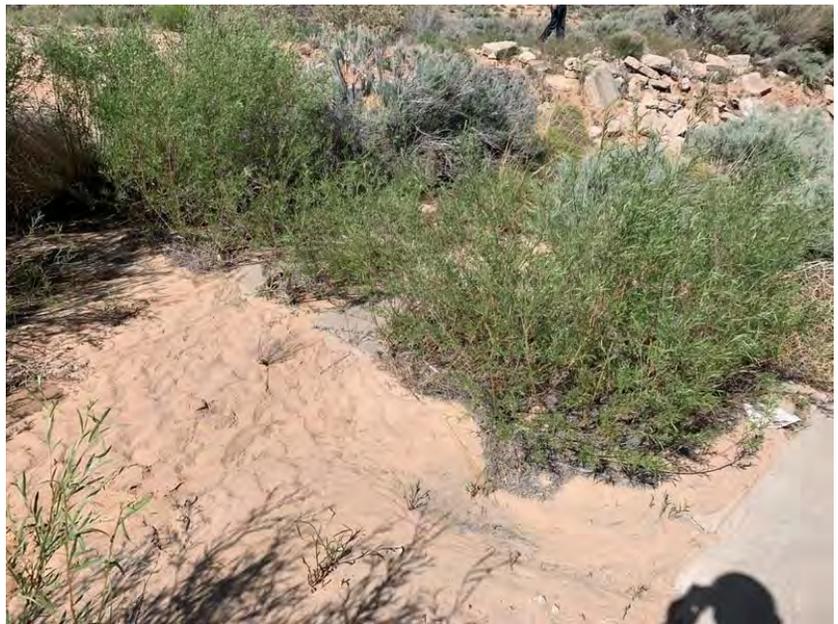
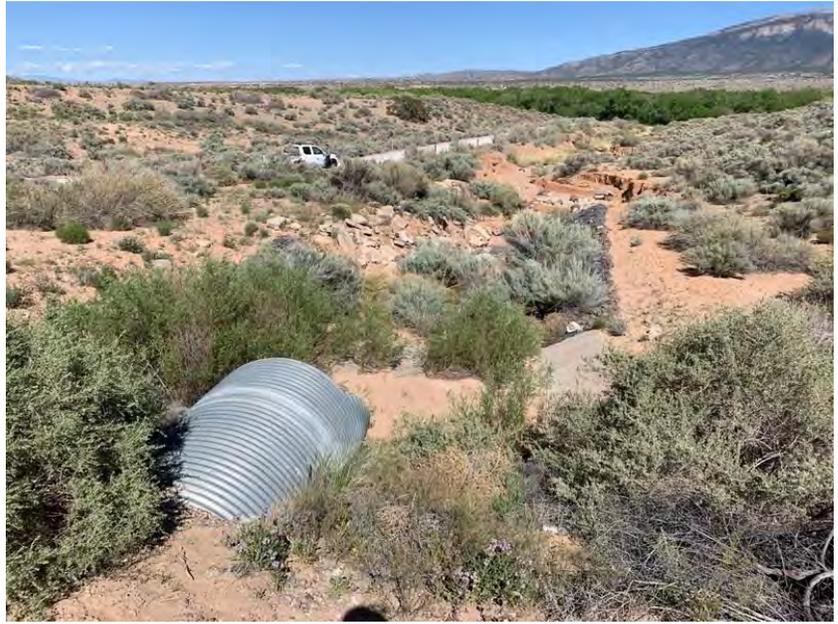
Heavy vegetation

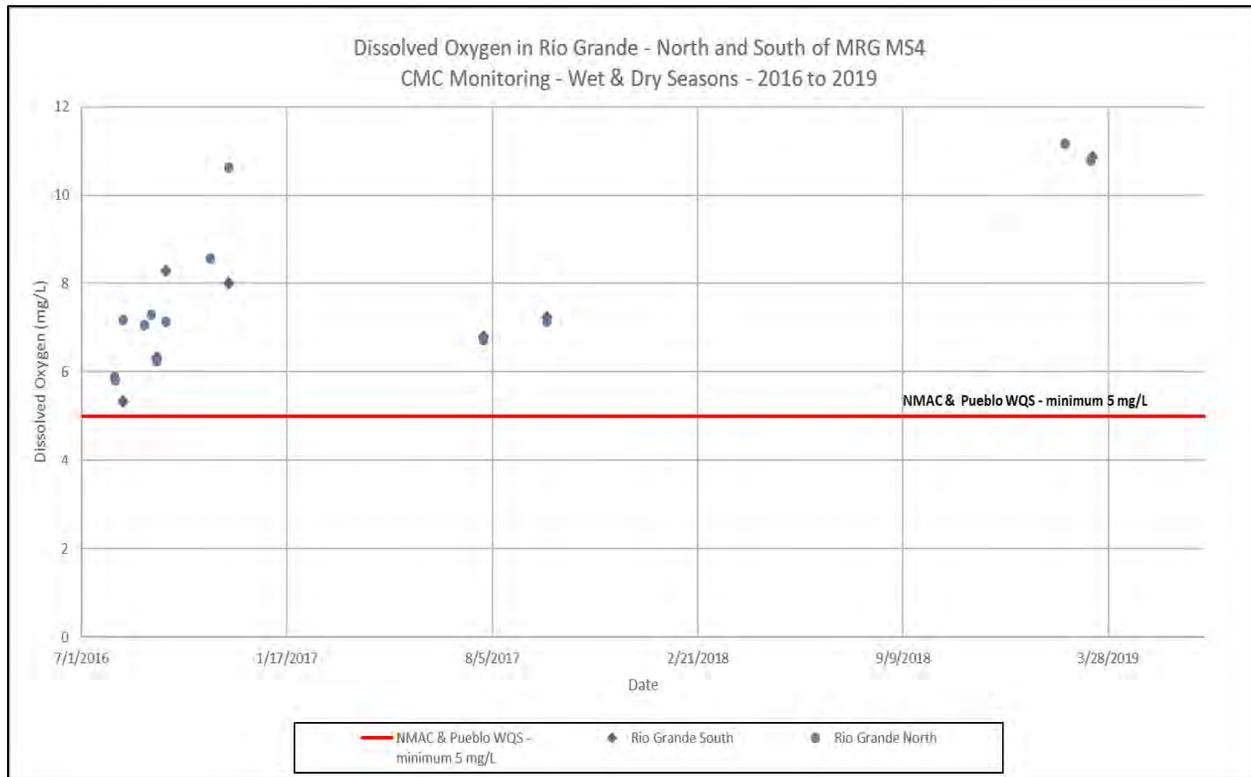
Figure 4: Dissolved Oxygen Results for Rio Grande CMC Monitoring – FY 2016 through FY 2019 Wet & Dry Season

Dissolved oxygen is a water quality concern in the Rio Grande if it is below 5 mg/L. None of the samples taken from the Rio Grande during the CMC FY 2019 dry season monitoring had dissolved oxygen values below 5 mg/L. This provides the MS4s with specific monitoring data showing that stormwater did not cause or contribute to exceedances of applicable dissolved oxygen water quality standards in the Rio Grande during the FY 2019 dry season. Refer to Figure 4 for dissolved oxygen results and comparison to applicable WQS. For all of the CMC samples taken during this MS4 Permit Term, there have not been any dissolved oxygen readings below the 5 mg/L WQS.

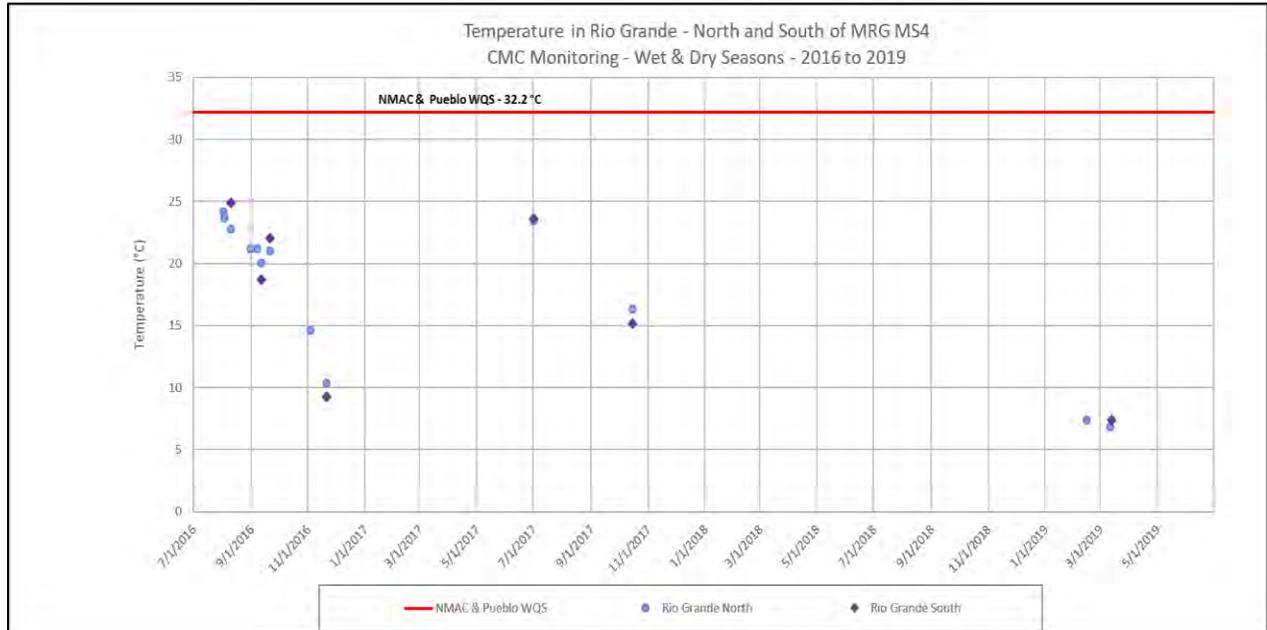
**Figure 5: Temperature Monitoring Results in Rio Grande
 CMC Monitoring – FY 2016 through FY 2019 Wet & Dry Season**

Temperature is listed in the WSB MS4 Permit as a special condition (currently only applicable to the City of Albuquerque and AMAFCA). Past data submitted to EPA and NMED has demonstrated that stormwater discharges into the Rio Grande are not raising the Rio Grande temperature above the WQS. The data collected during this CMC FY 2019 dry season monitoring supports this conclusion. All the temperature field readings taken in the Rio Grande during the CMC FY 2019 dry season were below 32.2°C (90 °F) - the WQS for the State of New Mexico and for the Isleta and Sandia Pueblos. Refer to Figure 5 for temperature results and comparison to applicable WQS. For all of the CMC samples taken during this MS4 Permit Term, there have not been any temperature readings above the 32.2°C WQS.
